ROAD SAFETY AUDIT

Bartlett Street

Town of Northborough

10/28/2021

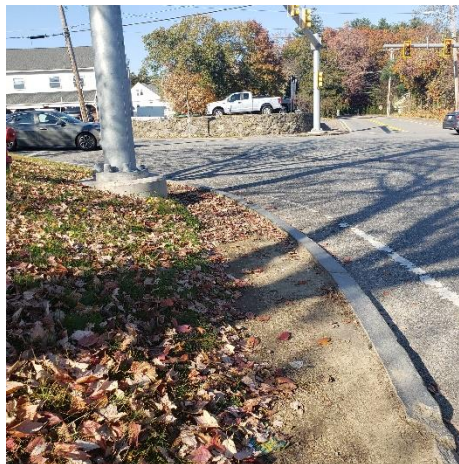
Figure 5: Tire Ruts on Bartlett Street

Observations: It was observed that large vehicles such as tractor trailers or school buses had difficulty turning onto Bartlett Street from both sides of Main Street. This was made evident at the RSA as tire marks were observed over the curb in the grass from vehicles turning right on to Bartlett Street from Main Street (eastbound) (have photos). The RSA team also commented on lack of adequate pedestrian infrastructure given the high usage of high school students using the intersection to access their homes and retail establishments on both sides of Main Street. Among the four approaches to the intersection there is only one signalized crosswalk that is on the east side of the intersection. Residents voiced concerns that right-on-red turning movements are allowed and that many drivers do not pay attention to pedestrians in the crosswalk when attempting to make a right-turn maneuver from Bartlett Street onto EB Main Street. Additionally, there are only sidewalks on one side of Bartlett Street and no sidewalks on Main Street despite access to retail businesses and Saint Bernadette’s School at the intersection.

- Work with MassDOT to develop long term design recommendations for the intersection. The design should include accommodations for trucks turning in and out of Bartlett Street and pedestrian improvements at the intersection and access to retail businesses on Main Street.
- Work with MassDOT as a short-term measure to consider moving back the stop bar on Bartlett Street to allow for additional turning radii for trucks turning into Bartlett Street.
- Work with MassDOT to evaluate current signal timing with special attention for left turns onto Main Street.
- Work with MassDOT to evaluate short and/or mid-term improvement for right turns from Main Street EB into Bartlett Street SB and Bartlett Street NB to Main Street EB.

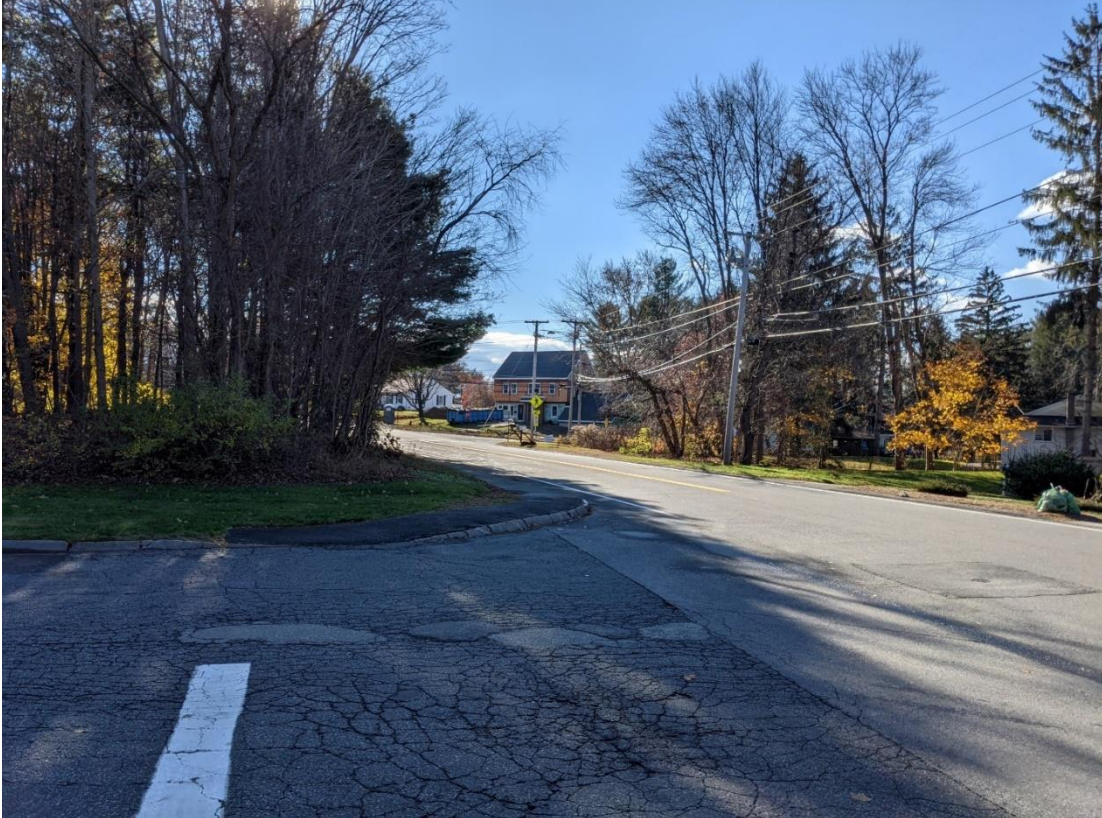
Figure 9: Hemlock Drive Limited Sight Lines

Bartlett Street and Hemlock Drive – A T-intersection with both roads having one travel lane in each direction. There is a stop sign at the end of Hemlock Drive. Vegetation impedes the line of sight of motorists exiting Hemlock Drive on to Bartlett Street. The position of the stop line is set far back, and drivers must move past the stop line to observe traffic movements.

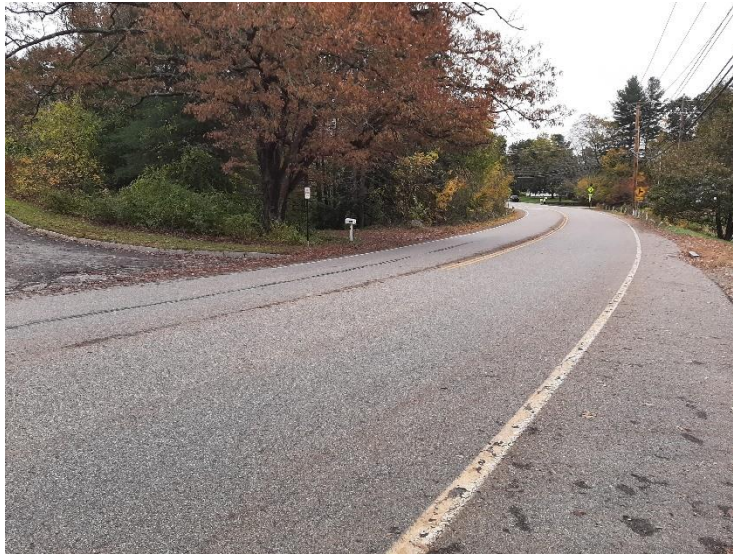
Figure 14: Poor Sightline from Jenkins Drive as Bartlett Curves

Bartlett Street and Jenkins Drive – A T-intersection with no marked lanes on Jenkins Drive. Bartlett Street has one travel lane in each direction. Bartlett Street curves at this intersection. There is a poor line-of-sight for vehicles turning onto Jenkins Drive from Bartlett Street heading east. Additionally, vehicles departing Jenkins Drive on Bartlett Street have a poor line-of-sight in both directions.

Observations: The entrance and exit for Jenkins Drive is on a curve of Bartlett Street traveling west. The combination of the curve in the road and the vegetation limit sightlines for vehicles entering and exiting Jenkins Drive. Some residents use Stirrup Brook Lane to get onto Bartlett Street for better sightlines and improved safety. Right next to Jenkins drive there is a hidden driveway for an independent property that is not visible from Bartlett Street.

- Consider adding blind driveway signs on westbound lane after crosswalk warning vehicles of upcoming driveways and streets.
- Clear brush from side of road to increase visibility for all vehicles.

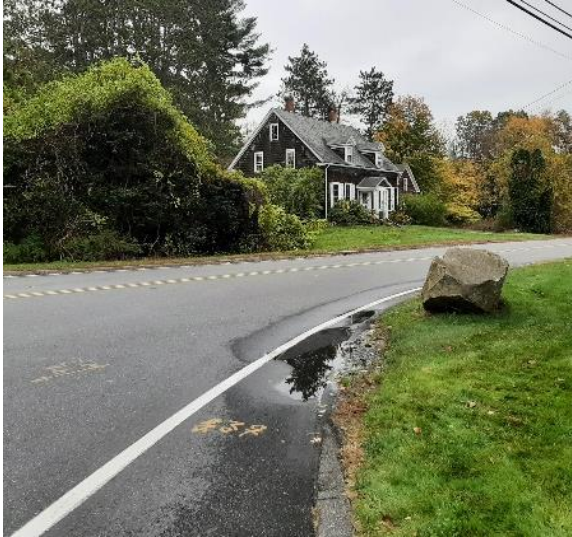
Figure 15: Potential Safety Hazard Rock Placed by Residents to Prevent Vehicles on Grass

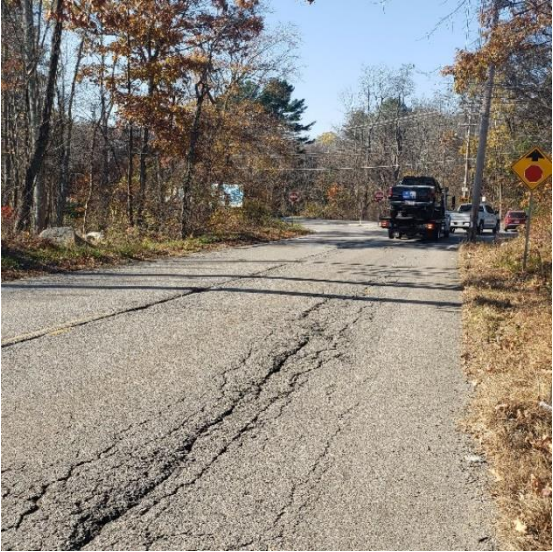
Figure 23: Pavement on Cedar Hill Road in Marlborough

Observations: The intersection was recently designed with new channelized islands and geometry. Stakeholders and residents at the RSA were generally happy with the redesign. Participants at the RSA made note of the poor pavement condition of Cedar Hill Street in Marlborough. A representative of ARHS also stated that the pavement conditions on Cedar Hill Street in Marlborough was one of their biggest concerns for student (teen driver) safety. A lack of lighting was noted at the intersection. Pedestrian infrastructure exists west of the intersection on Bartlett and the Aqueduct trail.

- Improve lighting at intersection.
- Consider communicating with Marlborough to work out a repaving plan for Cedar Hill Street.

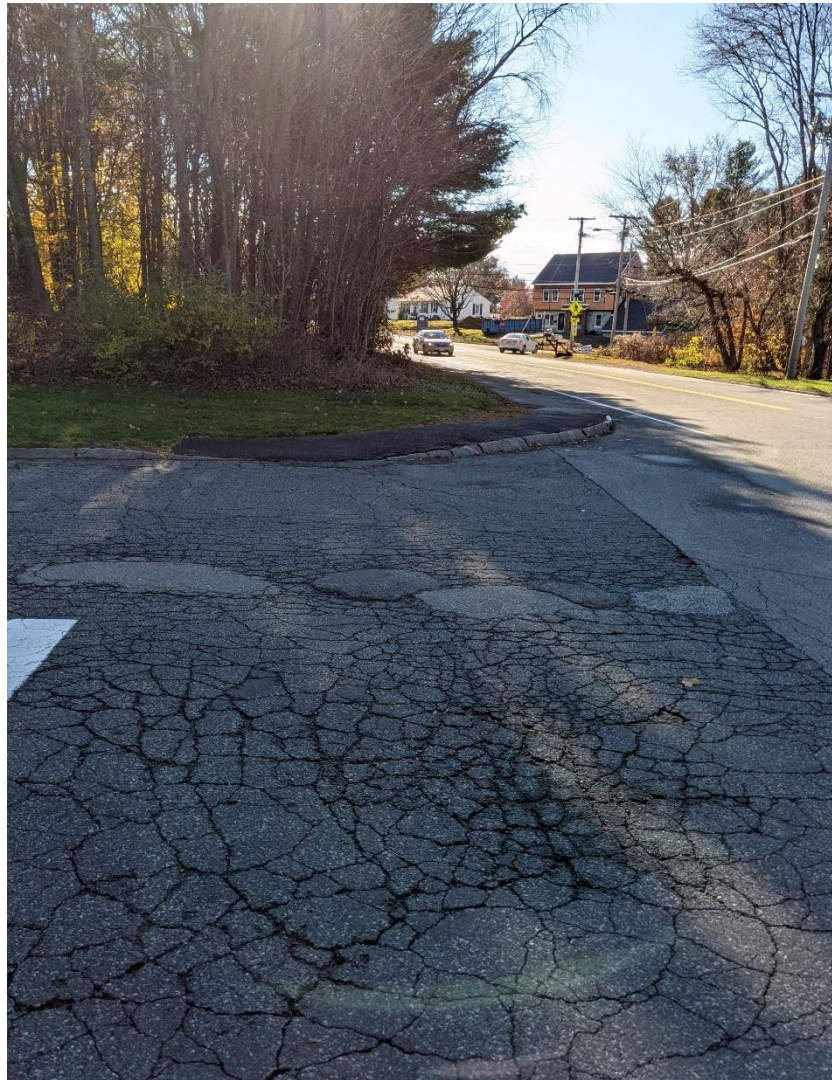
Figure 42: Hemlock Street Looking onto Bartlett Street

Observations: Vegetation currently obstructs the line of sight for motorists exiting Hemlock Street on to Bartlett Street. It was observed that the current stop line is placed far back from the road and makes it difficult to observe motorists traveling on Bartlett Street towards Route 20. Hemlock Street's pavement shows signs of wear through alligator cracking at the intersection.

- Clear back brush that impedes sight lines
- Repaint stop line closer to Bartlett Street
- Repave or seal parts of Hemlock Street

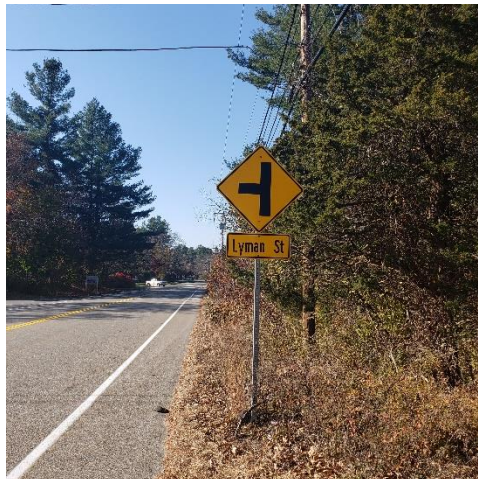
Figure 45: Signage for T-Intersection for Lyman

Observations: The intersection of Bartlett Street and Lyman Street had some major concerns during the RSA. Despite a 'stop sign ahead' on Lyman St approaching Bartlett St., residents and observers at the RSA noted that the actual stop signs on Lyman Street at Bartlett Street seem to sneak up on drivers. There have been multiple accidents at this location. During the RSA, there was no longer a guardrail on Bartlett Street as two vehicles had recently crashed through it. Another observation was that vehicles traveling on Bartlett Street predominantly WB occasionally stop although there is no stop sign on Bartlett Street (courtesy stops) for vehicles making a left turn onto Bartlett Street while exiting Lyman Street. This action often causes confusion for drivers behind the stopped vehicle on Bartlett Street causing hazardous driving behavior. There is signage directing traffic to Route 495 at the end of Lyman Street and the intersection has a streetlight.

- As a short-term measure consider adding reflectors on stop-sign pole and improve visibility/presence of the advance warning signs on Lyman Street.
- Long – term improvement should consider intersection geometry redesign and box widening at Lyman Street.
- Mid-term improvement should consider adding a flashing stop sign for Lyman Street.
- Consider adding flashing warning signs for Bartlett Street.
- Long term improvement should consider advisory shoulders to narrow the road.
