CENTRAL MASSACHUSETTS
METROPOLITAN PLANNING ORGANIZATION

Berlin: Route 62 Corridor Profile

August 2022

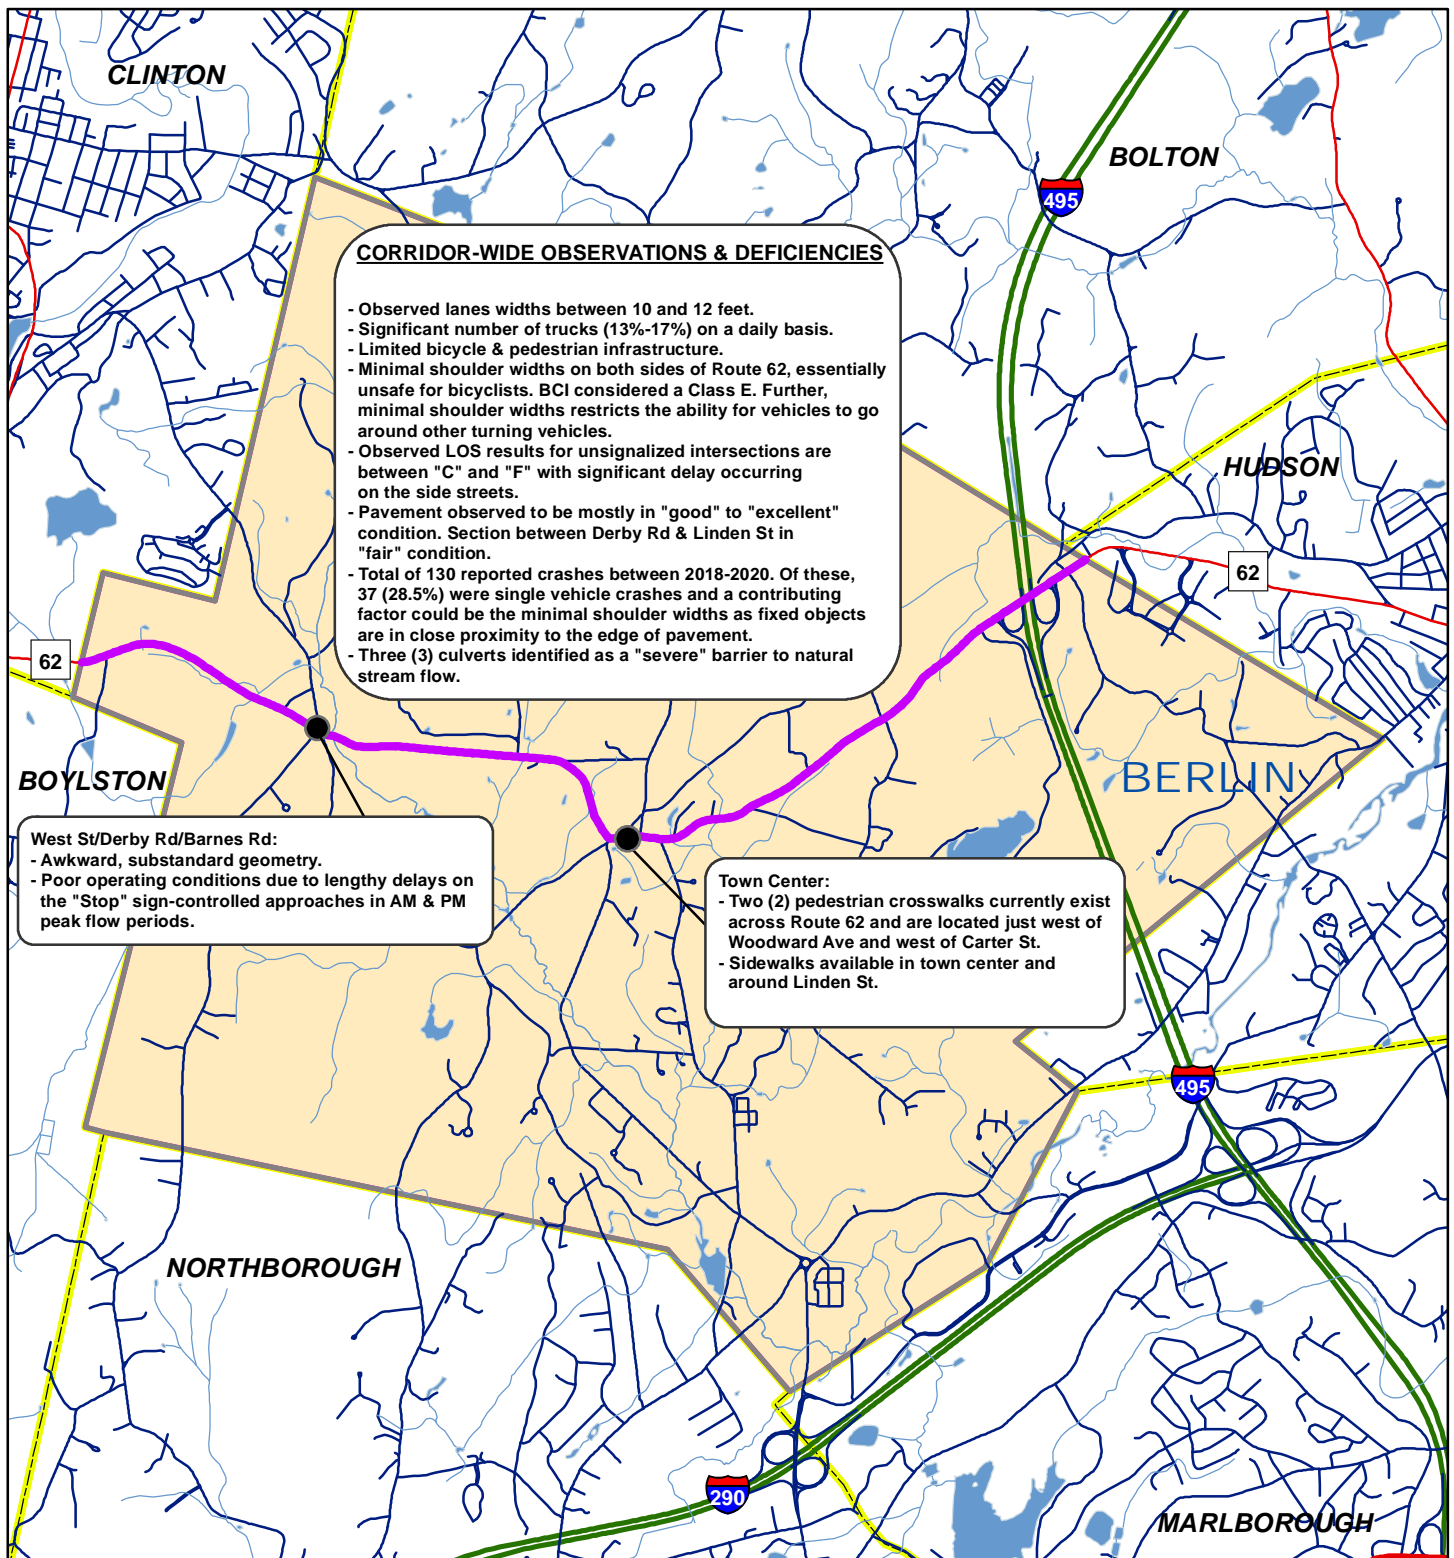
Observations & Deficiencies

- Observed lane widths are between 10 and 12 feet. Traffic flows include a significant number of observed large trucks, ranging from 13% to 17% on a daily basis on Route 62 in Berlin.

- Minimal shoulder widths along both sides of Route 62 in Berlin. As a minimal shoulder width of 5 feet is practically non-existent along the corridor, it is essentially unsafe for bicyclists – other than highly skilled riders. The Bicycle Compatibility Index (BCI) score is considered a Class “E”, the second lowest defined ranking. Further, the minimal existing shoulder widths often restrict the ability for vehicles to go around other turning vehicles as well as, for example, delivery and rubbish removal trucks.

- Observed Level of Service (LOS) results for the four unsignalized intersections are between a “C” and “F” with significant delay occurring on the side streets.

- Pavement observed to be mostly in “good” to “excellent” condition. The only section of road determined to be in “fair” condition is between Derby Road and Linden Street.

- Awkward, substandard geometry at the Route 62 / West Street / Derby Road / Barnes Road intersection should be addressed due to poor observed operating conditions, resulting from lengthy delays on the “Stop” sign-controlled approaches during both the morning and evening peak flow periods.

- Through field observations and subsequent analysis, three (3) culverts along Route 62 in Berlin have been identified as “severe” barriers to natural stream flow. As a severe barrier, besides often adversely impacting both fish and wildlife passage, culvert water flows could be increasingly restricted and lead to both pipe and roadway failure under severe weather conditions.

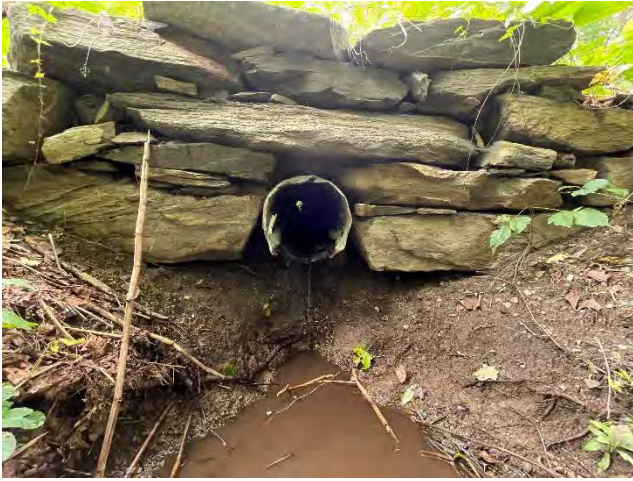
Culvert #1 – Outlet Side

There was a mix of observed conditions for the 9 structures along the Route 62 study corridor. There are three structures (#1, #2 & #5) that are considered as a "severe" barrier. Next, there are four structures (#3, #4, #7 & #8) that are a "moderate" barrier. There is also one structure (#6) that is an insignificant barrier in Berlin and one structure (#9) that the structure was unable to be assessed and scored. For this structure, the outlet pipe could not be found. All structures are made of either concrete, metal, or rock/stone and range in length between 36 feet to 60 feet. Following the table, **Figures 7A & 7B** show photos taken in the field of the major drainage structures assessed along Route 62.

Assigned Map #	Host Community	Structure Materials	Approx. Pipe Size	Approx. Length	NAACC Passability Score	Additional Notes
1	Berlin	Metal	1' x 1'	42'	0.079	Culvert located near 113 Boylston Rd. Outlet in poor condition.
2	Berlin	Metal	2' x 2'	58'	0.186	Culvert located near 85 Boylston Rd. Outlet in poor condition.
3	Berlin	Metal	5' x 5'	45'	0.634	Culvert located near 83 Boylston Rd. Outlet in poor condition and structure is rusting.
4	Berlin	Concrete	5' x 10'	40'	0.776	Culvert located just east of Derby Rd.
5	Berlin	Concrete	2' x 2'	36'	0.186	Culvert located near 68 West St. Two structures and one is in poor condition.
6	Berlin	Concrete	4' x 2'	49'	0.901	Culvert located near 38 West St.
7	Berlin	Metal	4' x 4'	50'	0.693	Culvert located to the west of Brewer Rd. Fencing across stream on outlet side.
8	Berlin	Concrete	2' x 2'	60'	0.657	Culvert located to the east of Oak St.
9	Berlin	Rock/Stone	3' x 3'	Unknown	No Score	Culvert located to the west of I-495 SB ramps. Large scour pool on inlet side. Outlet side not found. Assessment not complete.

- Regularly inspect & clean.
- Clear trash, vegetation, branches and other blockages.
- Inspect for adverse wildlife activity, ex. animal nests, beaver dams.
- As appropriate, maintain passage for aquatic & land animals.
- Install safety fencing where needed.
- As necessary, institute a planned, prioritized reconstruction and replacement program.
- Consider assessing all culverts in the host community using the NAACC Non-Tidal Aquatic Connectivity protocol to determine their aquatic passability and condition.
