CENTRAL MASSACHUSETTS
METROPOLITAN PLANNING ORGANIZATION

Sturbridge Route 20 Corridor Profile

December 2019

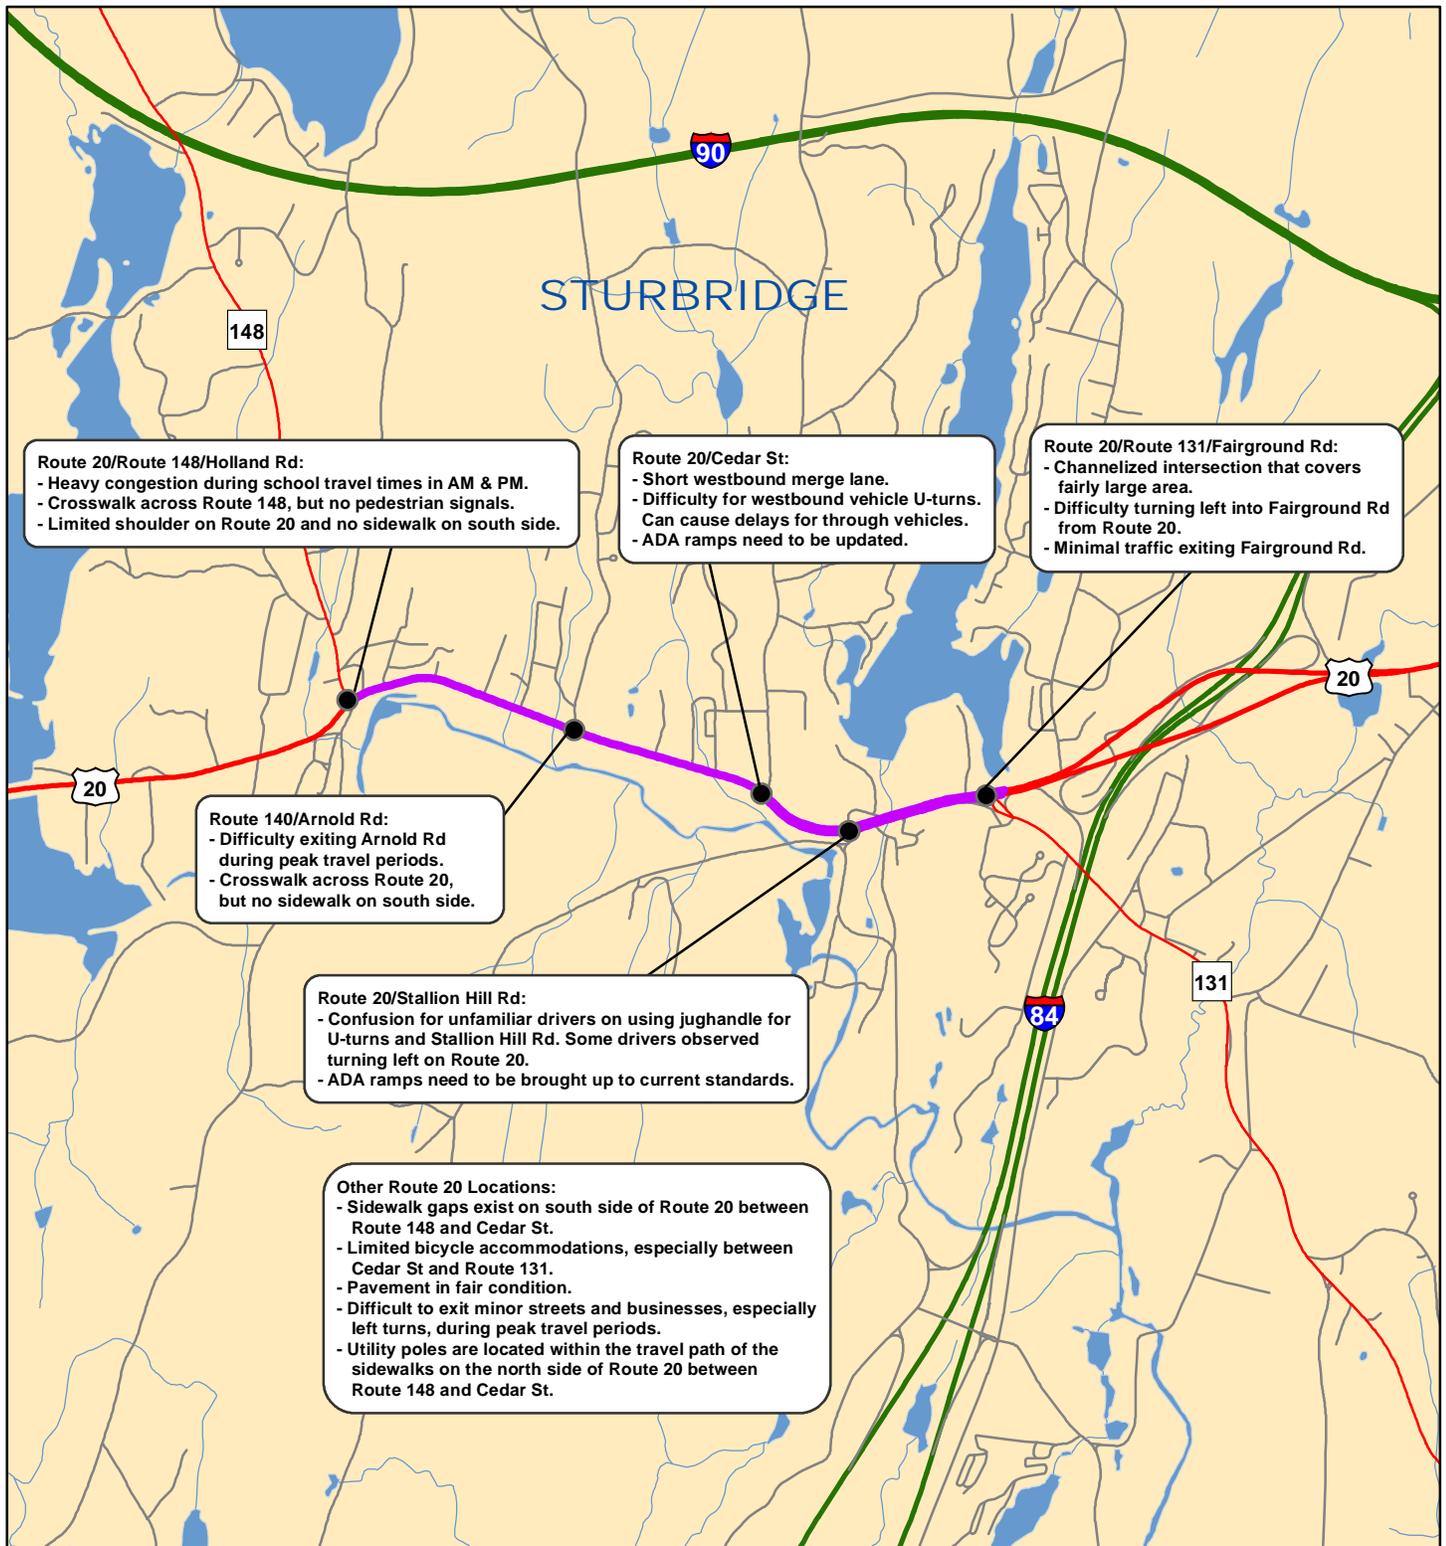
The following observations and existing deficiencies, also shown in **Figure 2**, were observed in Sturbridge along the Route 20 study corridor:

- The ADA ramps at the crosswalks need to be updated to current standards.
- U-turning vehicle can cause delays for through vehicles that use the inside lane.

- Some confusion for unfamiliar drivers to use jughandle for U-turns and Stallion Hill Road. Still, some people have been observed to turn left on Route 20 even though it is restricted.
- The ADA ramps at the crosswalks need to be brought up to current standards.

- Sidewalk gaps exist along the south side of Route 20 between Route 148 and Cedar Street.
- Limited bicycle accommodations, especially between Cedar Street and Route 131.
- Pavement is in fair condition throughout the entire study corridor.
- Difficult to exit minor streets and businesses, especially left turns, during peak travel periods.
- Between Route 148 and Cedar Street the utility poles are located within the travel path of the sidewalks on the north side of Route 20. This causes difficulties for wheelchairs attempting to maneuver along this section of sidewalk.

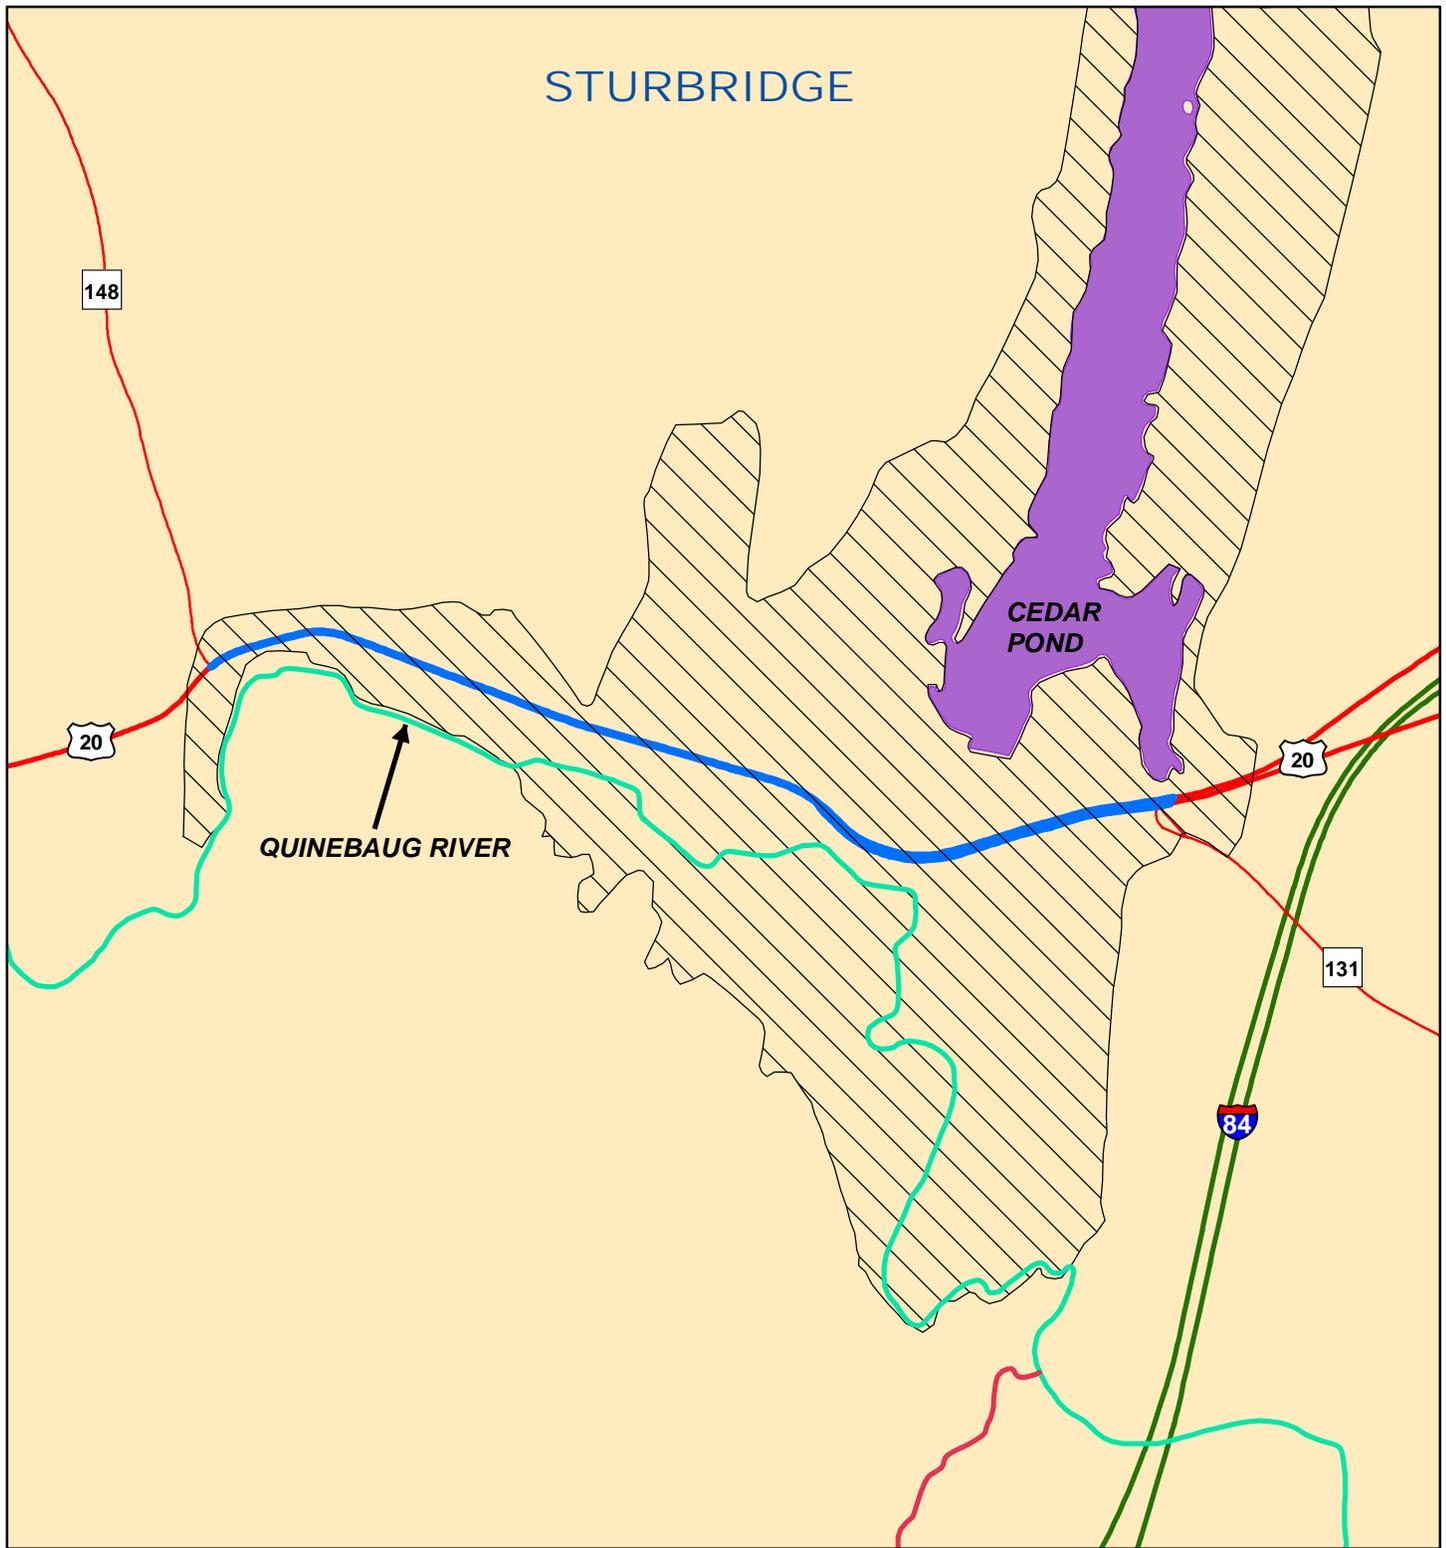
Sturbridge Impaired Waters & Wellhead Protection Areas

Figure 3 shows impaired waterways and wellhead protection areas in the study area. In Sturbridge, the entire Route 20 study corridor is within a wellhead protection area. Just south of Route 20 is the Quinebaug River, which requires a TMDL. Cedar Pond, located just north of Route 20, has an impairment, but it is not caused by a pollutant. The impairment is actually a non-native aquatic plant species.

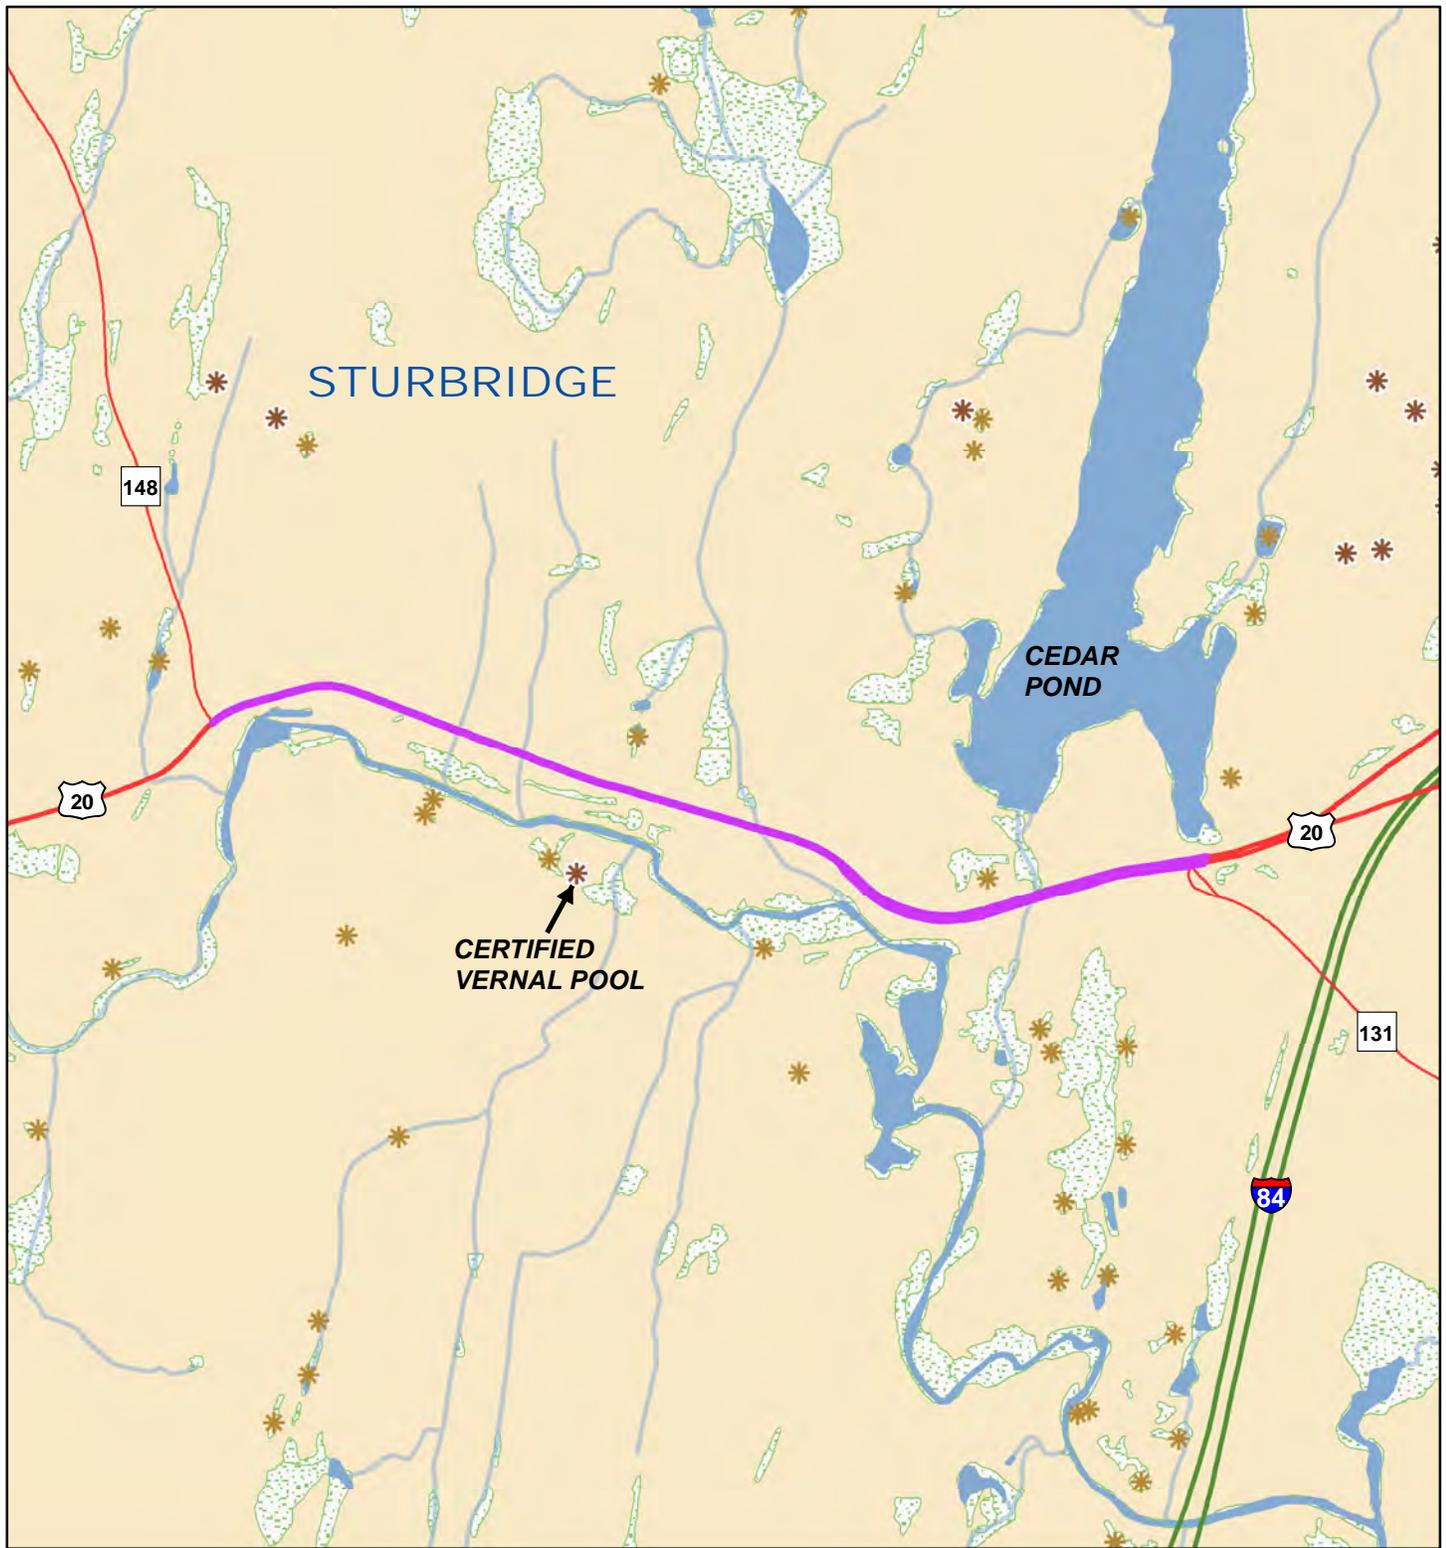
Figure 4 shows major watershed areas, vernal pools, and wetlands within the Route 20 study area. The entire Route 20 study corridor and surrounding area falls within the Quinebaug River Watershed. There are also numerous wetlands located north and south of Route 20, mainly near the Quinebaug River and Cedar Pond. In addition, there are some potential vernal pools nearby as well as one certified vernal pool. The majority of these certified and potential vernal pools are located on the southern side of Route 20, south of the Quinebaug River. Further study would be needed to investigate the types of species that inhabit the wetlands and vernal pools within the study area, and if any potential improvements would be detrimental to their existence.

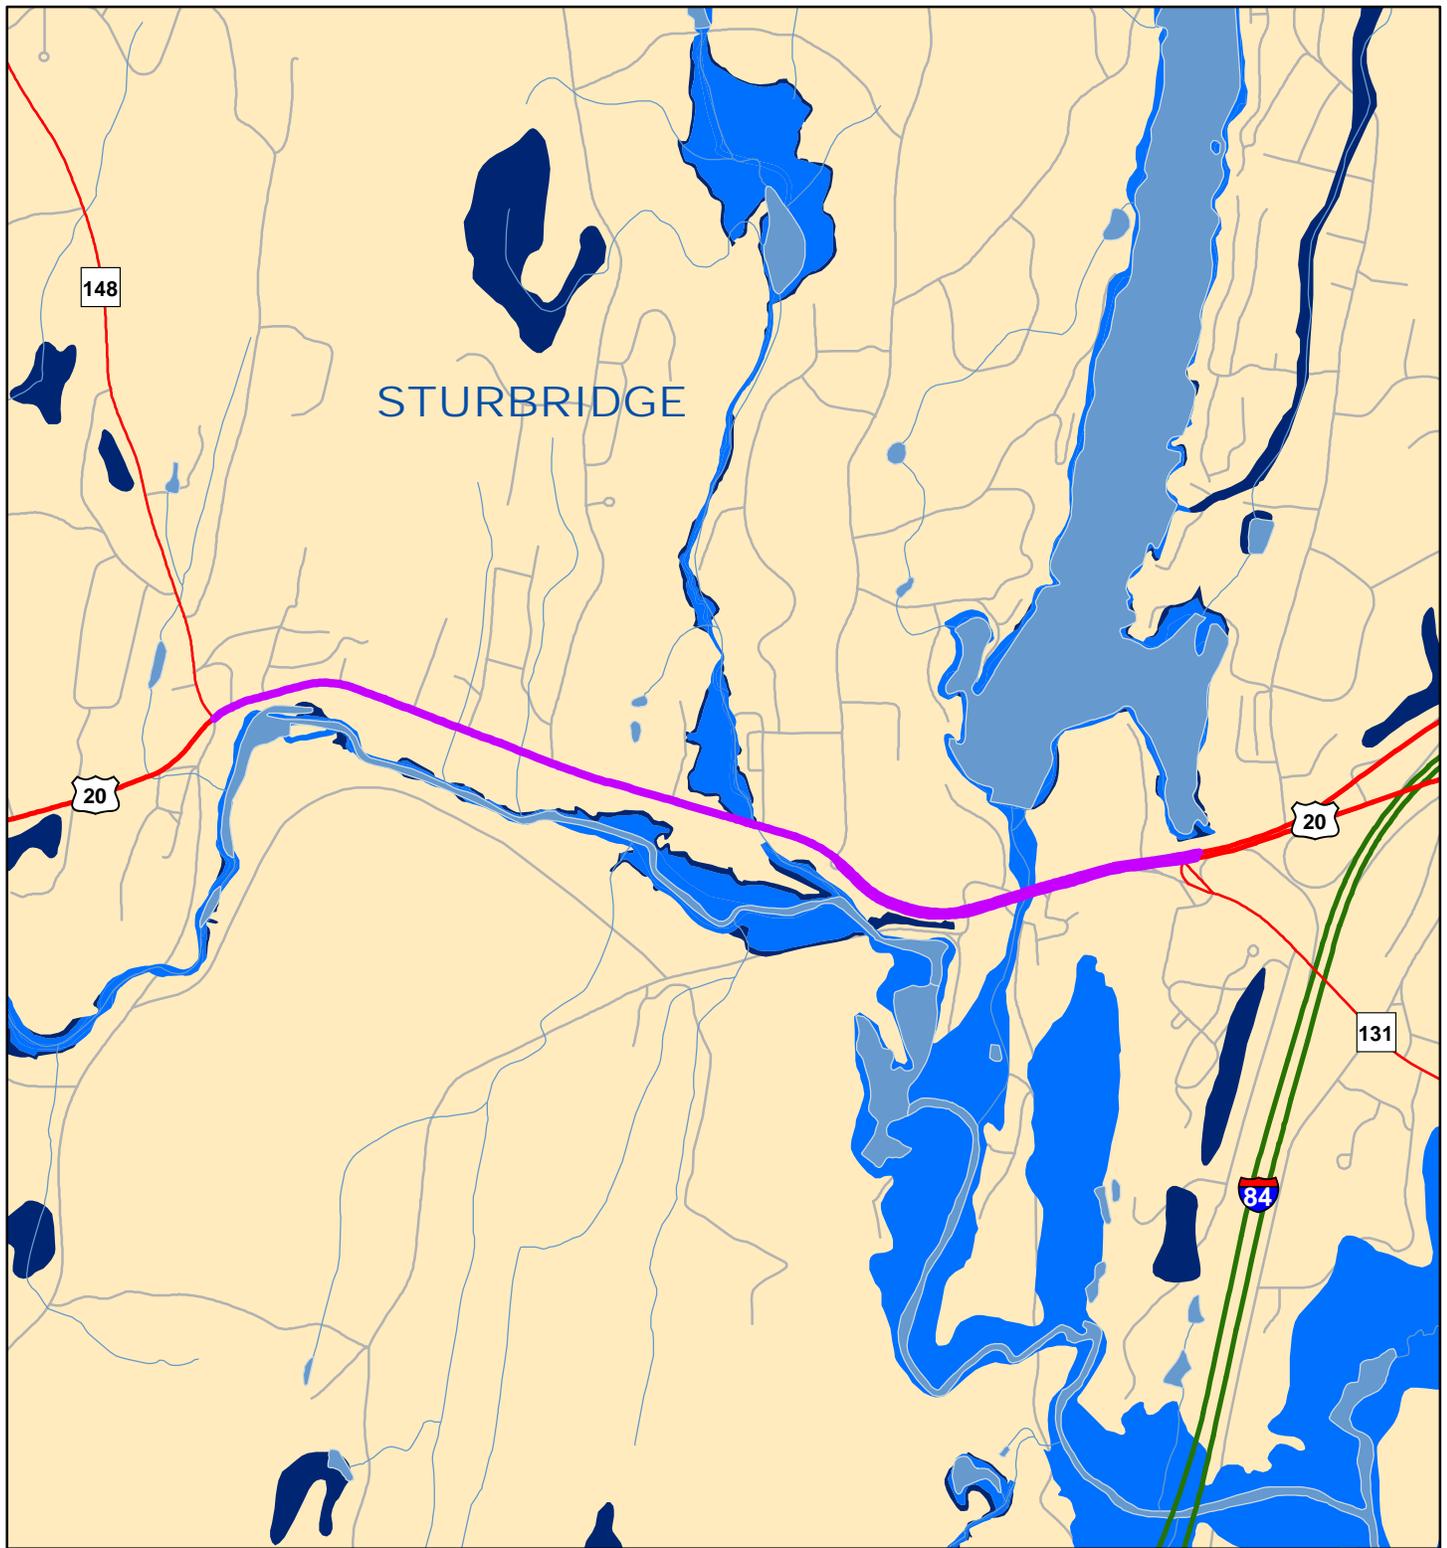
Sturbridge Flood Zones

Created by the Federal Emergency Management Agency (FEMA) in regards to National Flood Insurance Rates, **Figure 5** shows the 100 and 500 year flood zones near the study area. The 100 year flood zone means that there is a one percent annual chance of a flood within that defined area. The 500 year flood zone means that there is a 0.2 percent annual chance for a flood. The closer something is to the flooding source (e.g. river, stream, pond, etc.) the greater the risk of flooding. Flood zones are also used to calculate flood insurance rates for homes and businesses.

Along the Route 20 study corridor, the majority of the flood zones are 100 years. These 100 year flood zones are located along the Quinebaug River and Cedar Pond. Another area is located north of Route 20 between Arnold Road and Cedar Street. There are minimal 500 year flood zones located on some of the outer edges of the 100 year zones around the Quinebaug River.

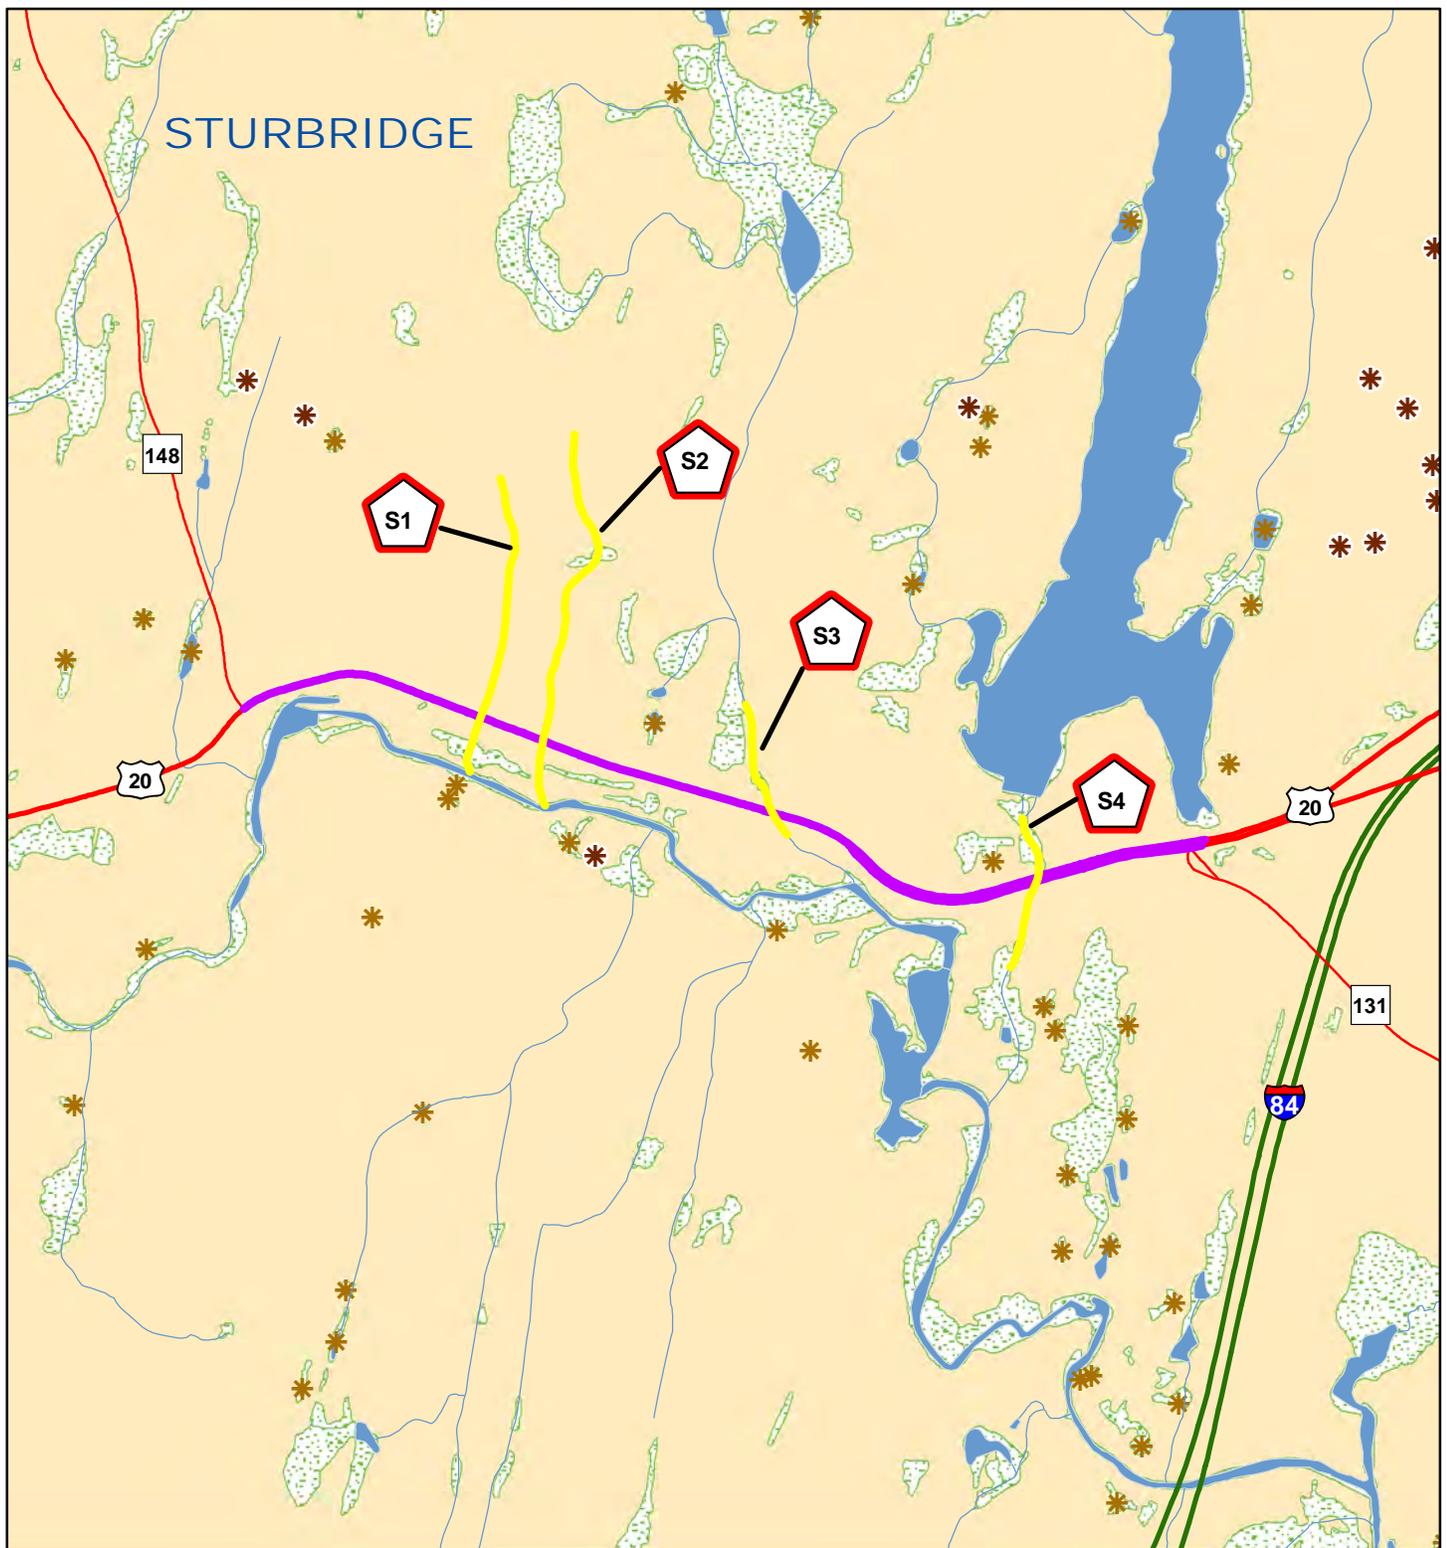
Sturbridge Major Drainage Structures

Using the previously described Environmental Profile maps compiled for this study using DCR, DEP, NHESP and FEMA data, the major water features intersecting Route 20 were identified through a GIS analysis. This mapping exercise allowed for the identification of major stream crossings along the study area of Route 20 in the town of Sturbridge. **Figure 6** shows the location of each identified major water crossing, denoted by a red pentagon symbol. Inside each pentagon is a number corresponding to the major drainage structures observed along Route 20.

Staff then conducted a field visit to locate and observe the various drainage structures along Route 20. In total, four distinct structures were reviewed within the study area. Accompanying the graphic, **Table 1** summarizes key information about each of the major drainage structures surveyed in the field. This information includes: pipe material and diameter, general condition, estimated pipe length, field observations, and any additional notes.

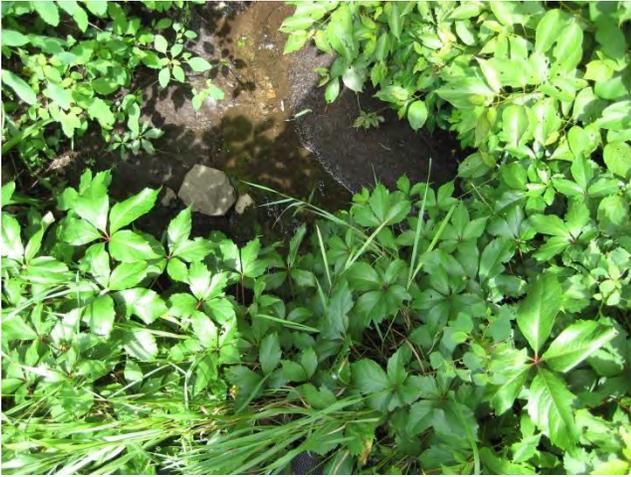
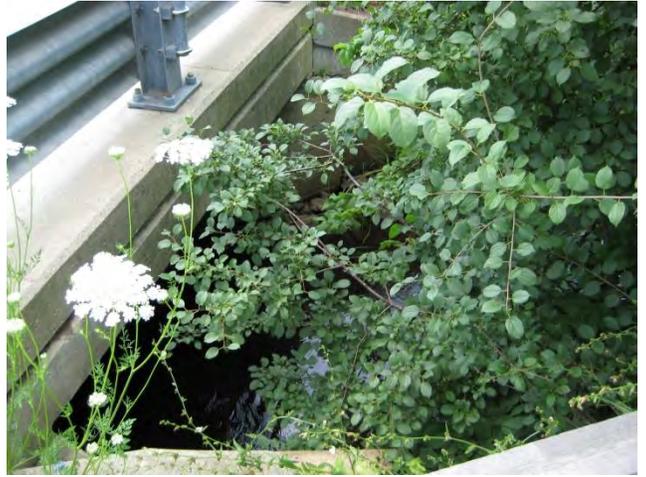
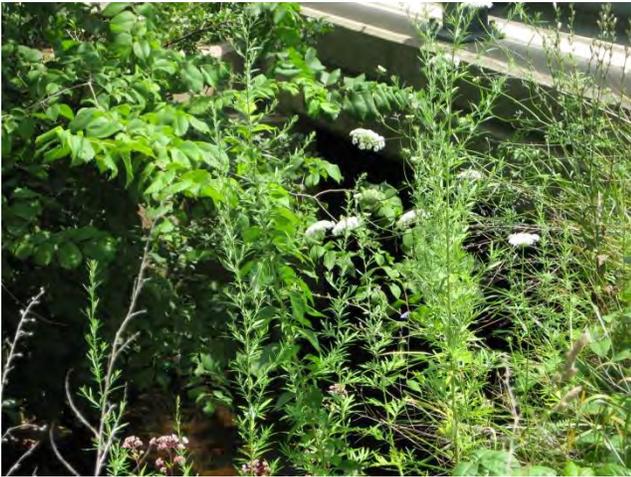
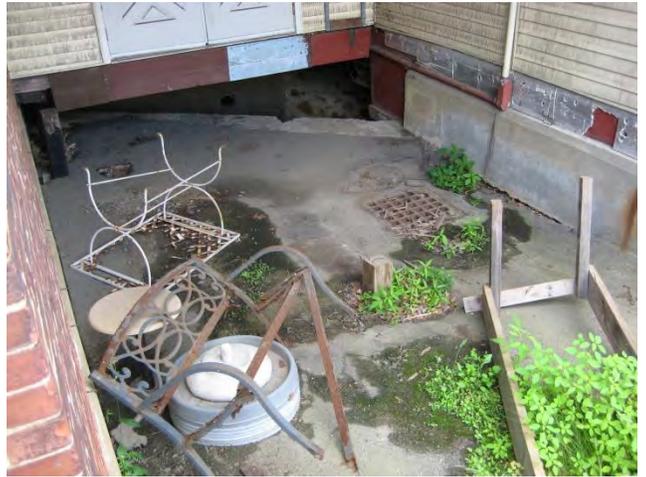
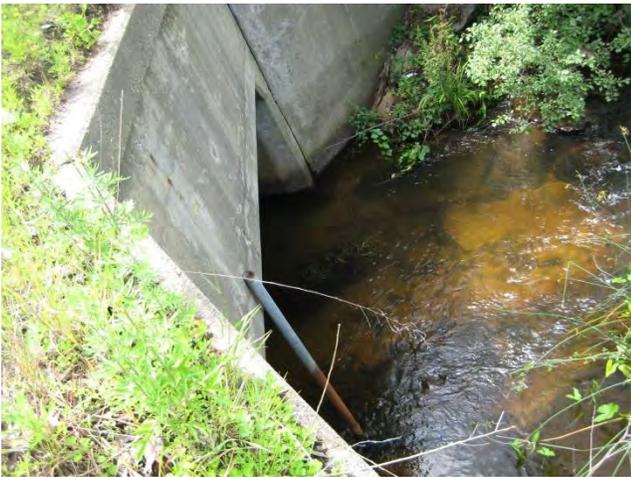
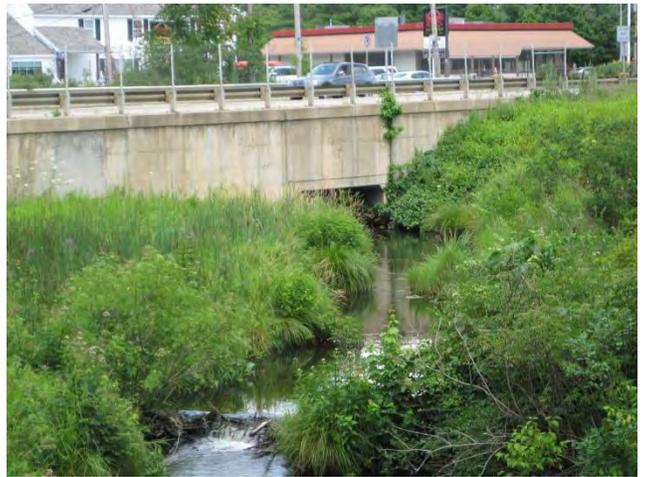
Figure 7
Sturbridge
Route 20 Major Drainage Structures Photos

All observed structures appear to be in good to excellent condition and all structures were made of concrete. Two of the structures (S3 & S4) are considered short span bridges. One of the structures flowed under the Yankee Peddler (433 Main Street) so the condition of the southern portion could not be analyzed. As for the two culverts (S1 & S2), one could not be found during the site visit (S1) while the other (S2) only had an inlet structure on the north side of Route 20. Field observations noted heavy vegetation at all locations. Following the table, **Figure 7** shows photos taken in the field of various major drainage structures along Route 20.

Assigned Map #	Host Community	Primary Materials	General Condition	Approx. Pipe Size	Approx. Length	Field Observations	Additional Notes
Major Culverts							
S1	Sturbridge					This Culvert Could Not be Located During Field Investigations	
S2	Sturbridge	Concrete	North Side - Fair/Good South Side - Unknown	3'	Unknown	North side has lots of vegetation. Noticed very little water.	No culvert outlet located on south side of road. There are two storm drains on south side, but not sure if they are connected to culvert.
Bridge Structures							
S3	Sturbridge	Concrete	North Side - Good South Side - Unknown	12'	85'	Guardrail on north side looks new. Lots of vegetation on north side and fallen dead branch in water near opening. South side is under the Yankee Peddler building and very little is visible.	Bridge #S-30-022 and is considered a short span bridge (10-20 ft). Built in 1850 and rebuilt in 1900. It is not Structurally Deficient.

S4	Sturbridge	Concrete	Good/Excellent	14'	70'	There is a beaver dam and lots of vegetation on the north side. Also, steep slopes and marshes. South side also has lots of vegetation. Guardrails on both side and extra protective fencing on south side.	Bridge #S-30-033 and is a short span bridge (10-20 ft). Built in 1956. It is not Structurally Deficient.

Based on the observations made in the field, the following provides a brief listing of specific maintenance and improvement options that target the Route 20 drainage structures observed in the field:

- Regularly inspect & clean.
- Clear trash, vegetation, branches and other blockages.
- Inspect for adverse wildlife activity, ex. animal nests, beaver dams.
- As appropriate, maintain passage for aquatic & land animals.
- Install safety fencing where needed.
- As necessary, institute a planned, prioritized reconstruction program for improved or replaced structures.
- Consider participation in UMass-Amherst “River and Stream Continuity Project”. This project surveys, assesses, and prioritizes road-stream crossing structures for replacement.

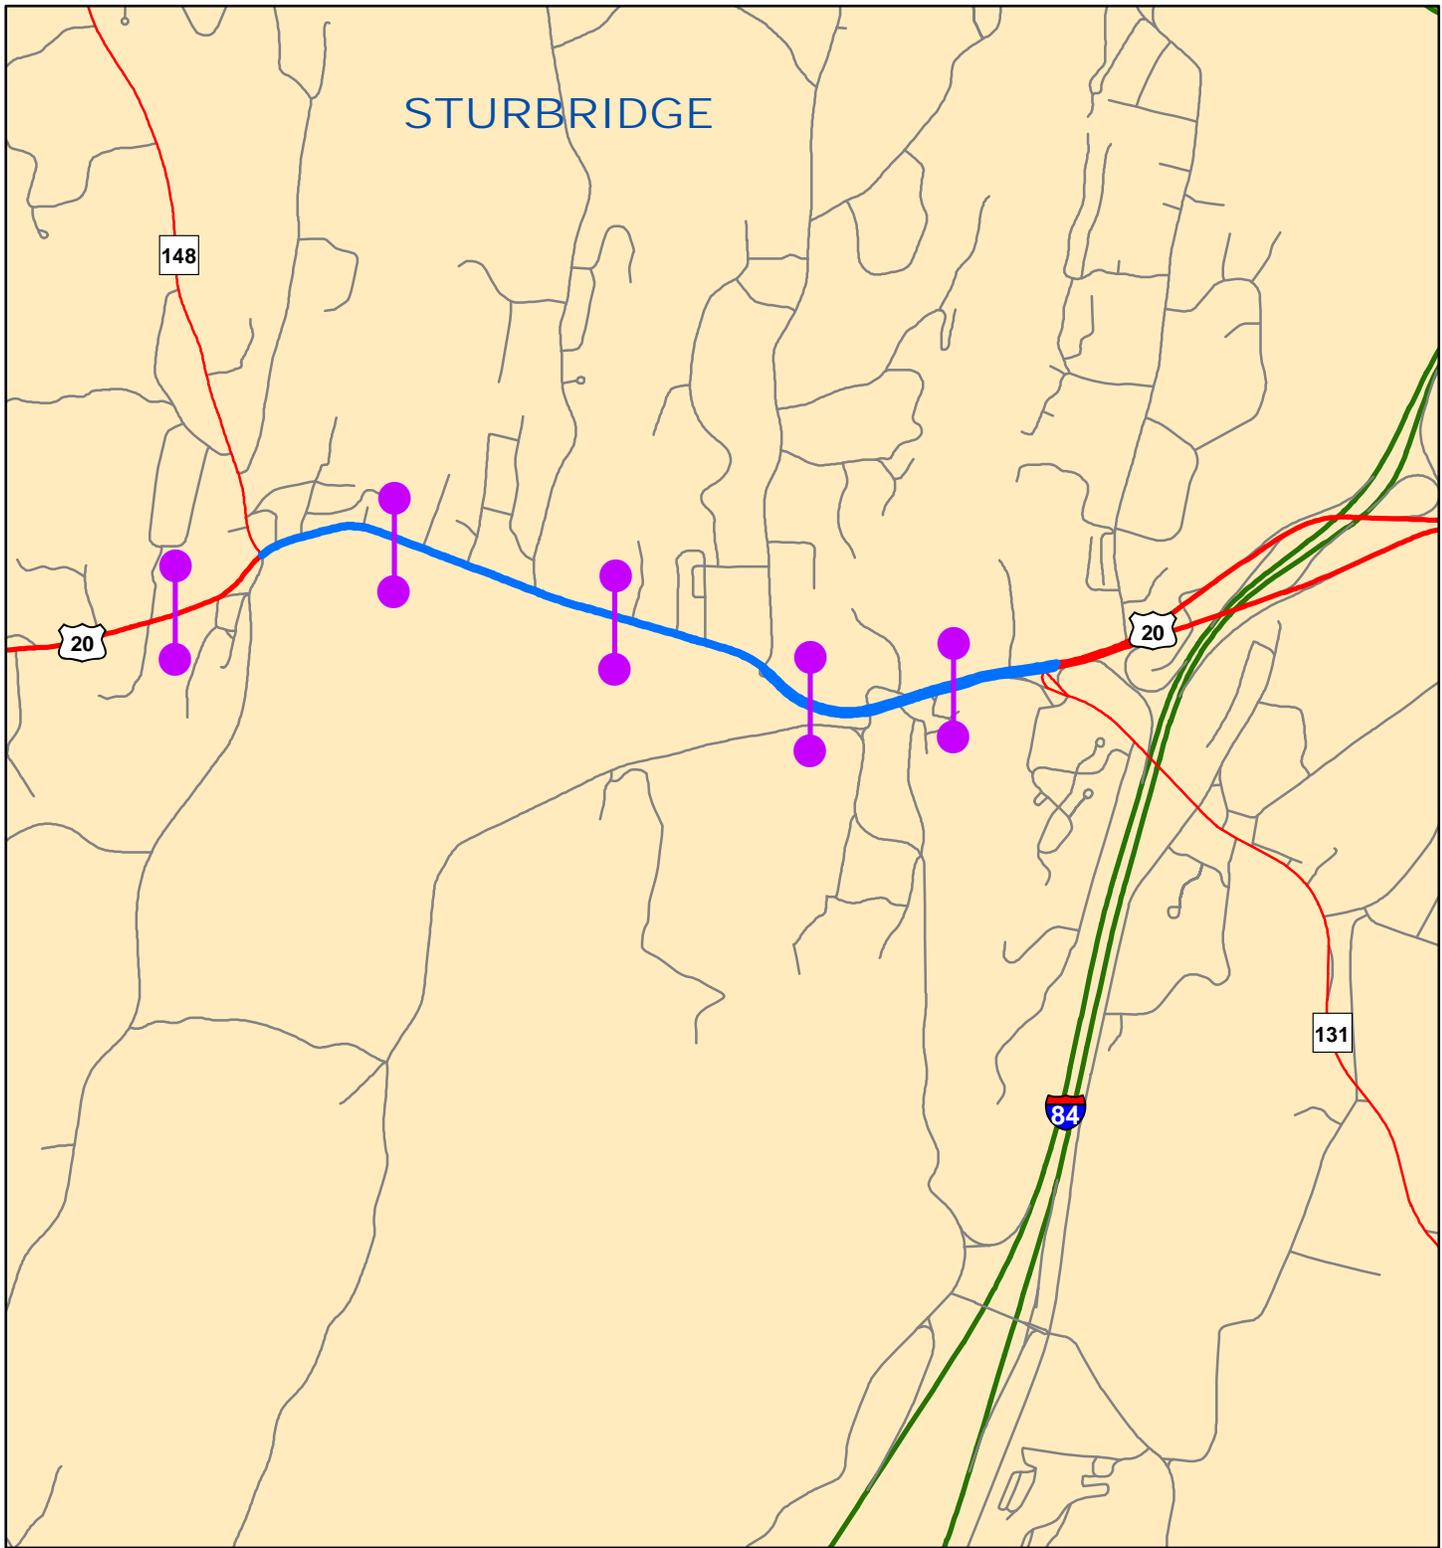
Figure 8

ATR Location	Date	Volume*
Route 20 West of Route 148	10/2/2018	8,850
Route 20 Between Route 148 & Arnold Road	10/2/2018	16,525
Route 20 Between Arnold Road & Cedar Street	10/30/2018	22,150
Route 20 Between Cedar Street & Stallion Hill Road	10/24/2018	25,200
Route 20 Between Stallion Hill Road & Route 131	12/5/2018	27,750

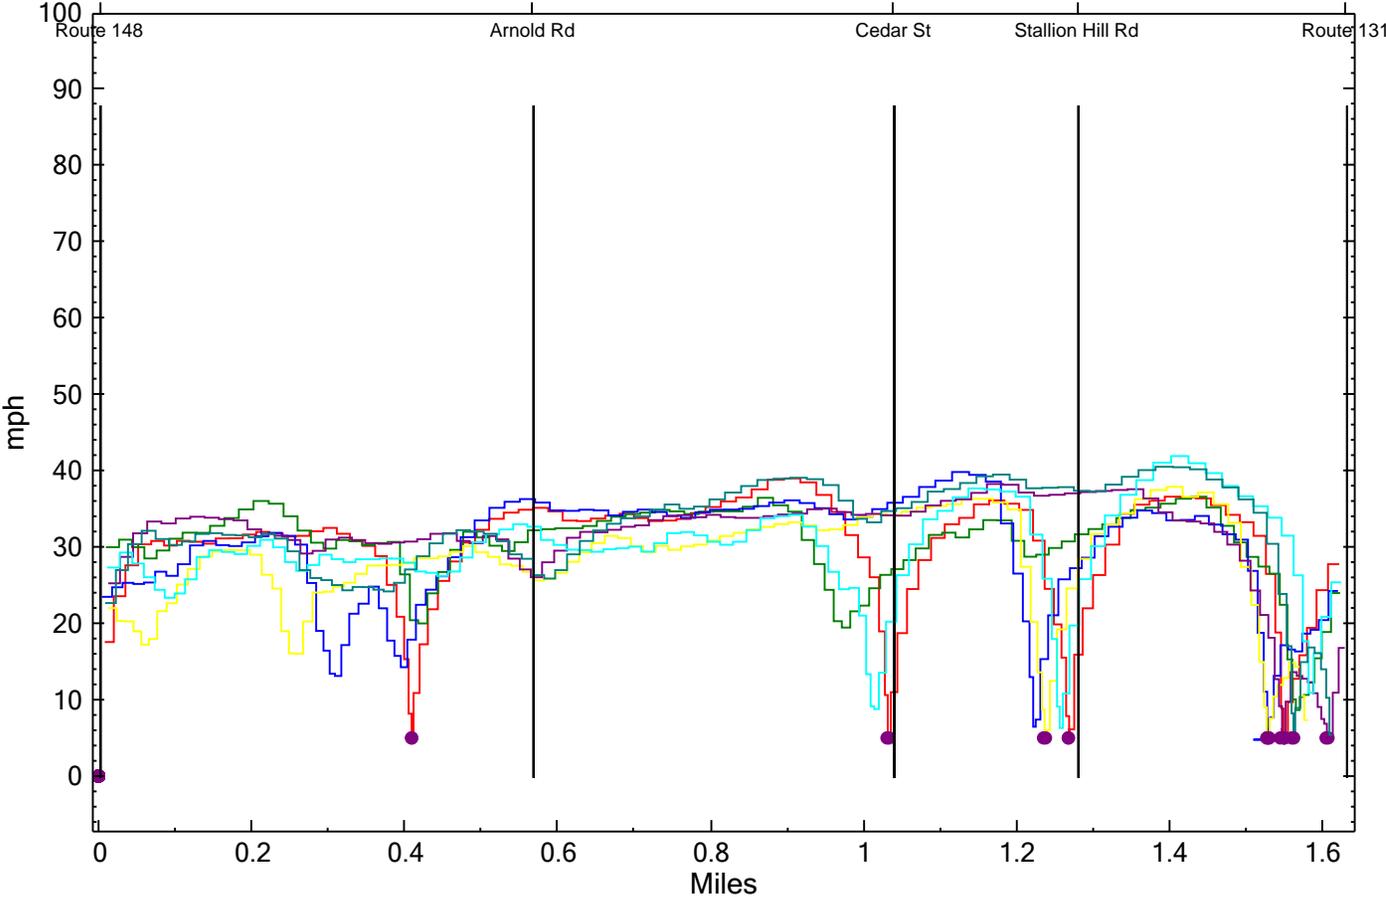
Figure 10

Speed Profile - Route 20 WB

ScaleX: 1 in = 0.25 Miles
ScaleY: 1 in = 25 mph

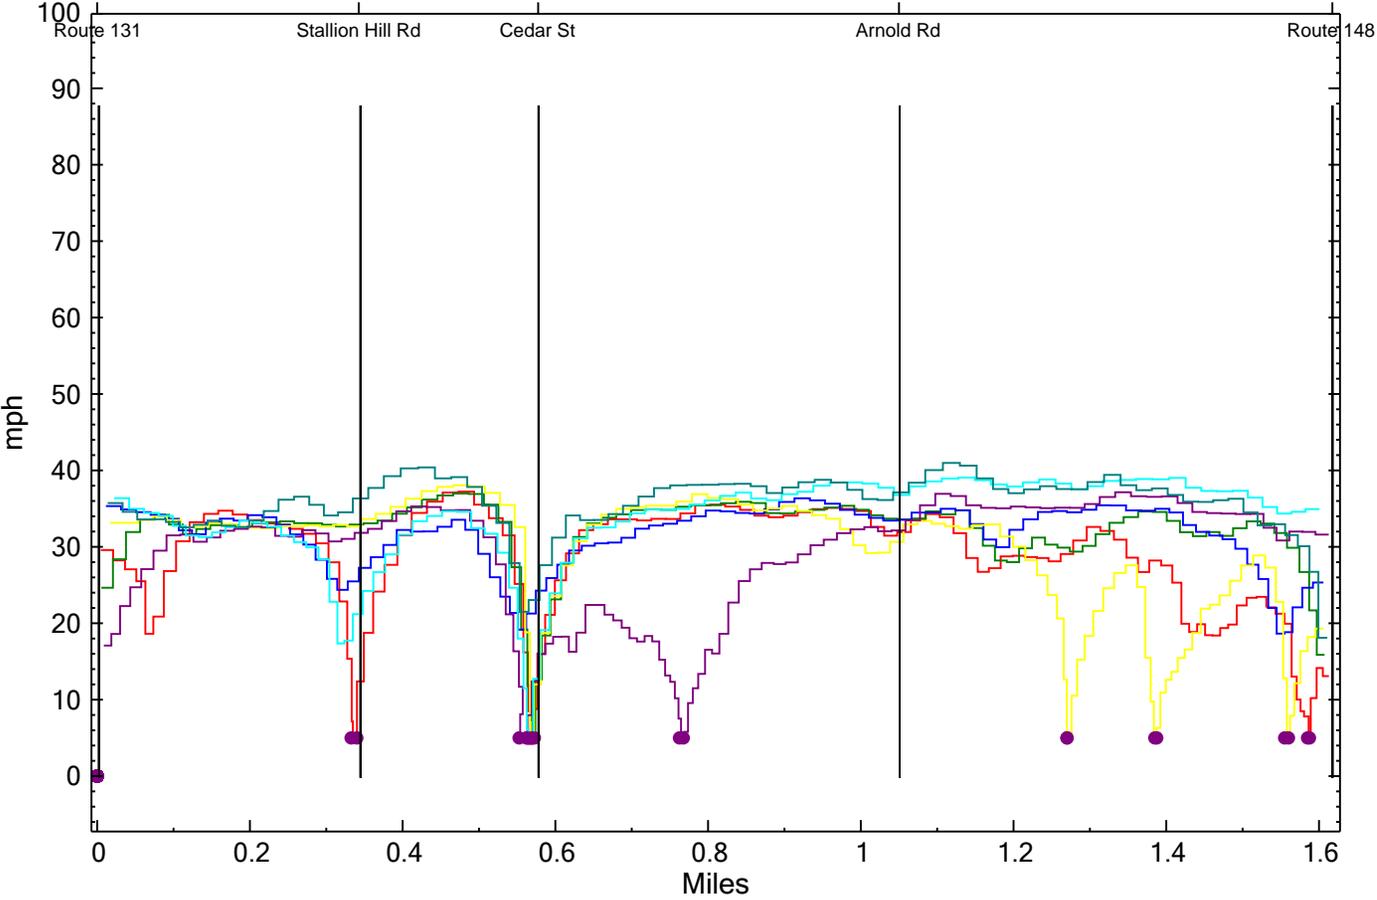
Figure 11

Speed Profile - Route 20 EB

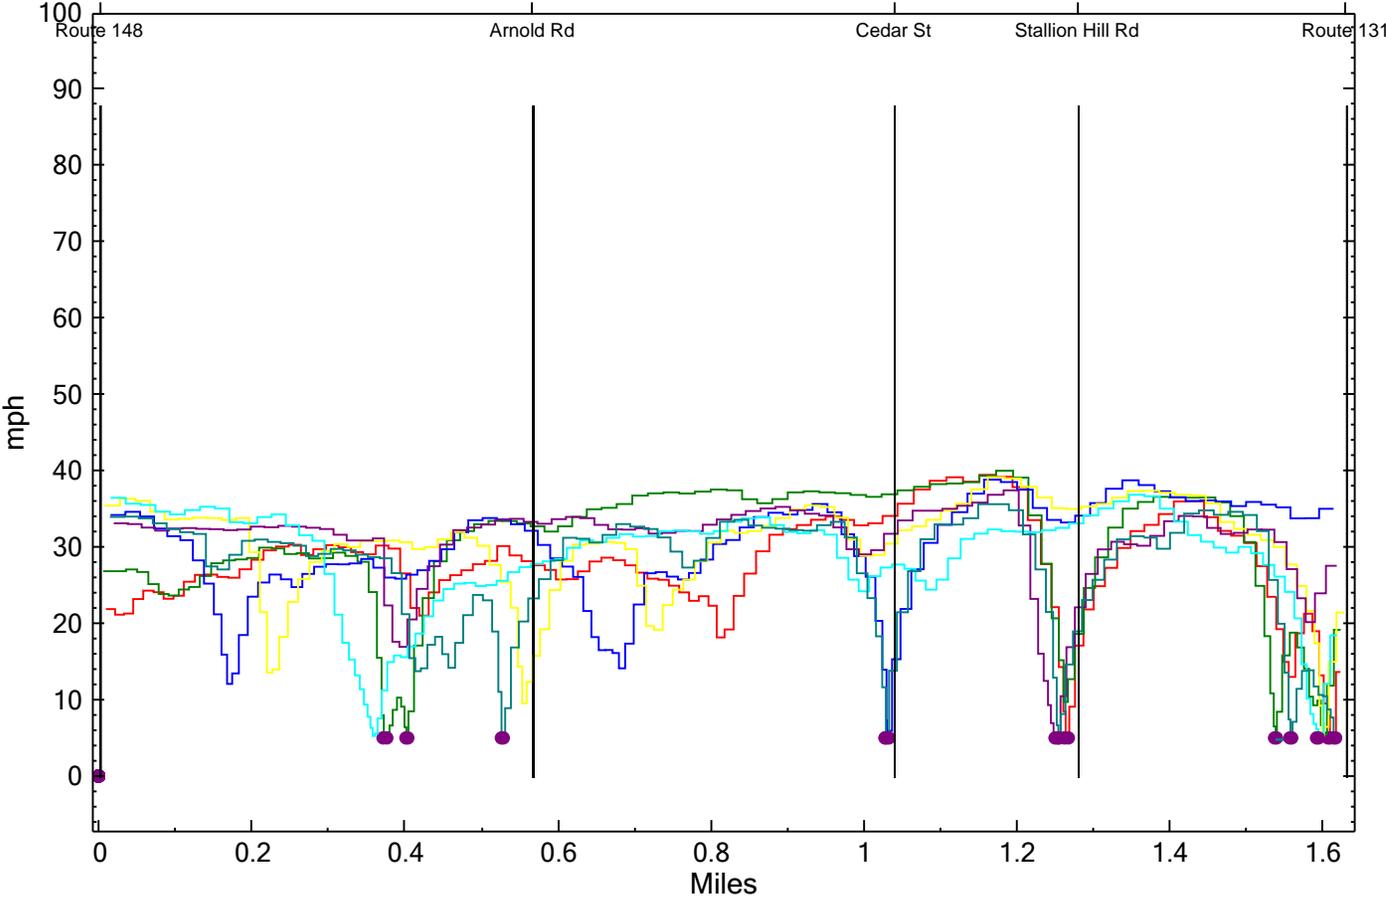
Figure 12

Speed Profile - Route 20 WB
