CENTRAL MASSACHUSETTS
METROPOLITAN PLANNING ORGANIZATION

Sturbridge Route 20 Corridor Profile

December 2019

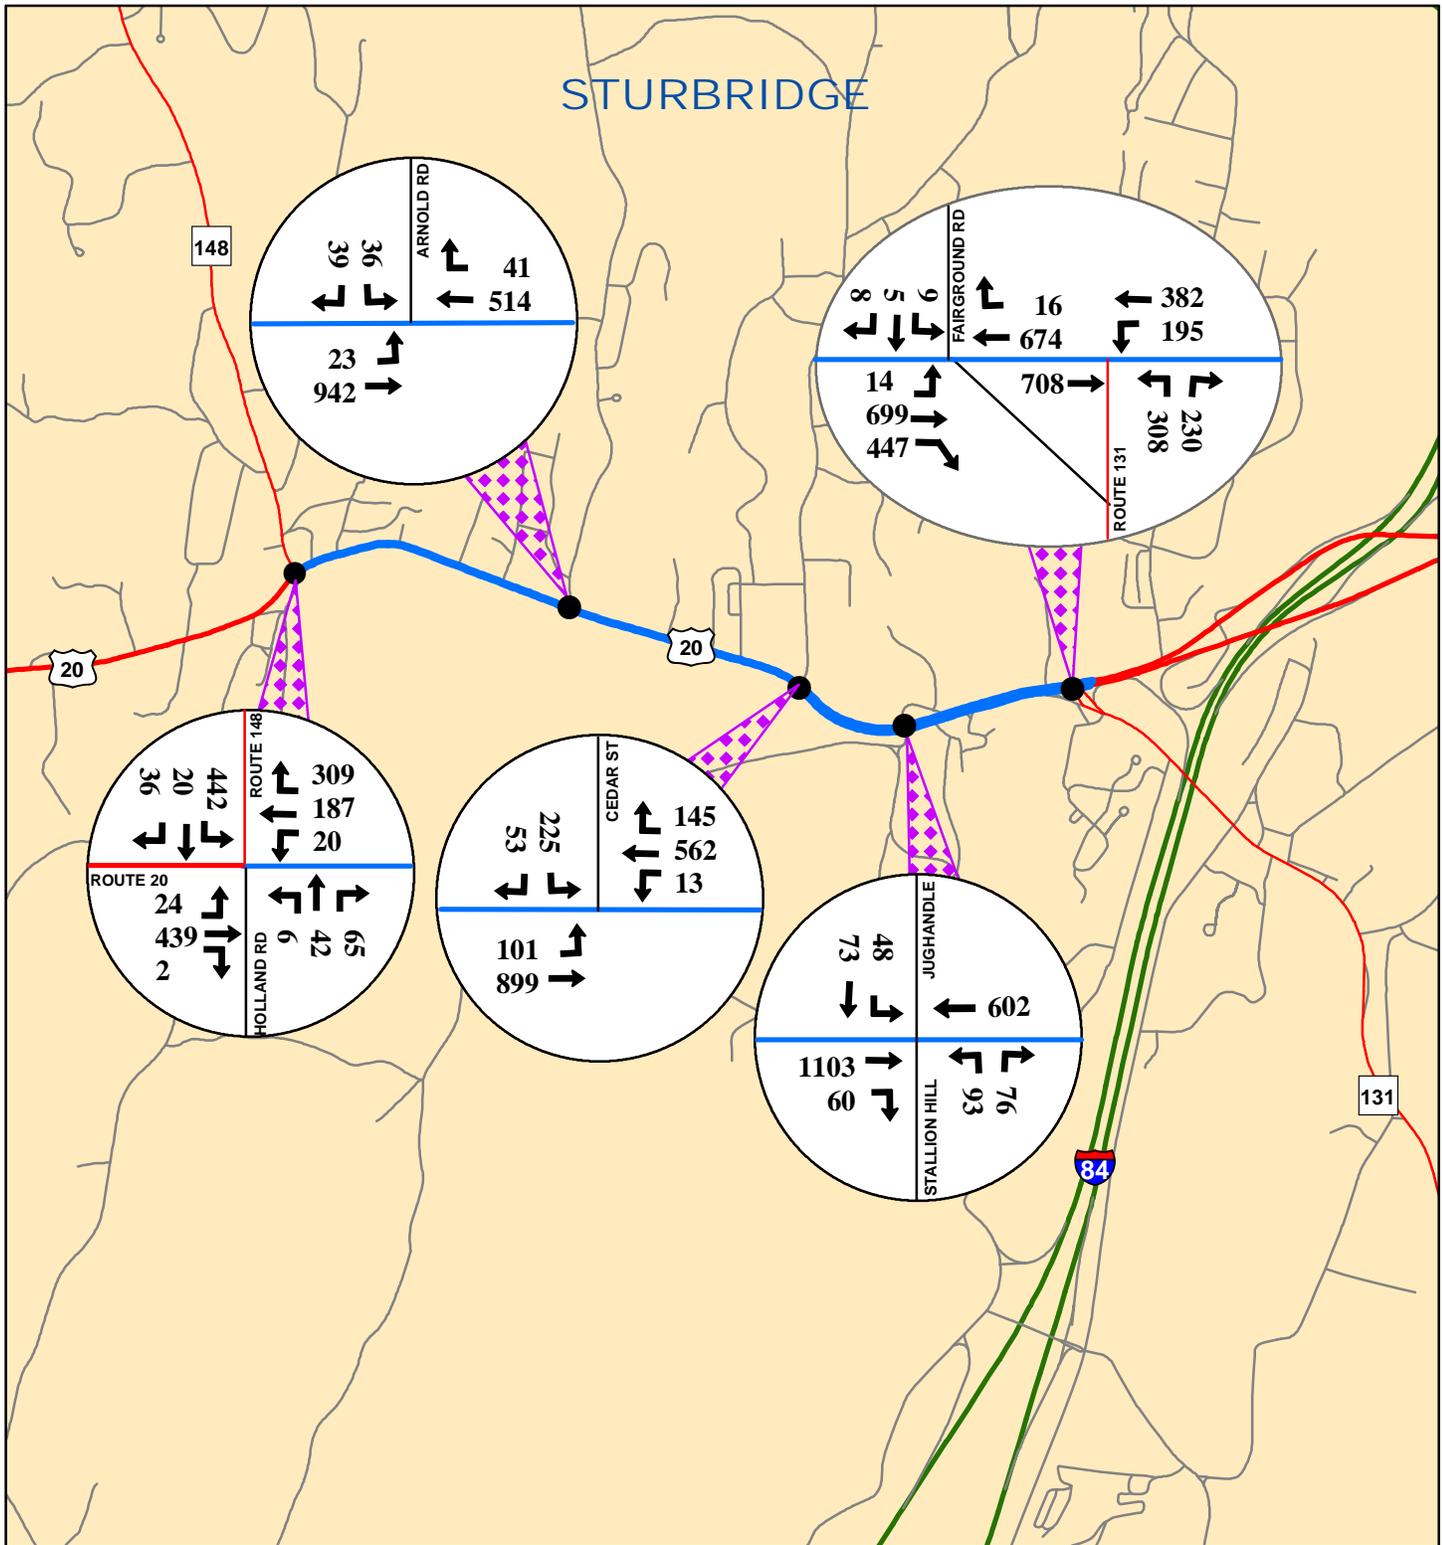
CMRPC conducted Turning Movement Counts (TMCs) at six focus intersections for this Corridor Study. All counts were completed in 2018 and during peak flow months while local schools were in session. In displaying these counts as a network, a “balancing” exercise was conducted to account for the typical addition and loss of traffic between adjacent study intersections (due to local streets, site drives serving major land uses, and other private driveways) as well as natural statistical variations encountered when TMCs are conducted on different weekdays. These adjusted volumes are shown in **Figure 13** and **Figure 14** as existing AM and PM peak hour traffic flows. (All TMC datasheets are provided in the document’s Technical Appendix).

Sturbridge Existing Traffic Flows
AM Peak Hour Period
Figure 13

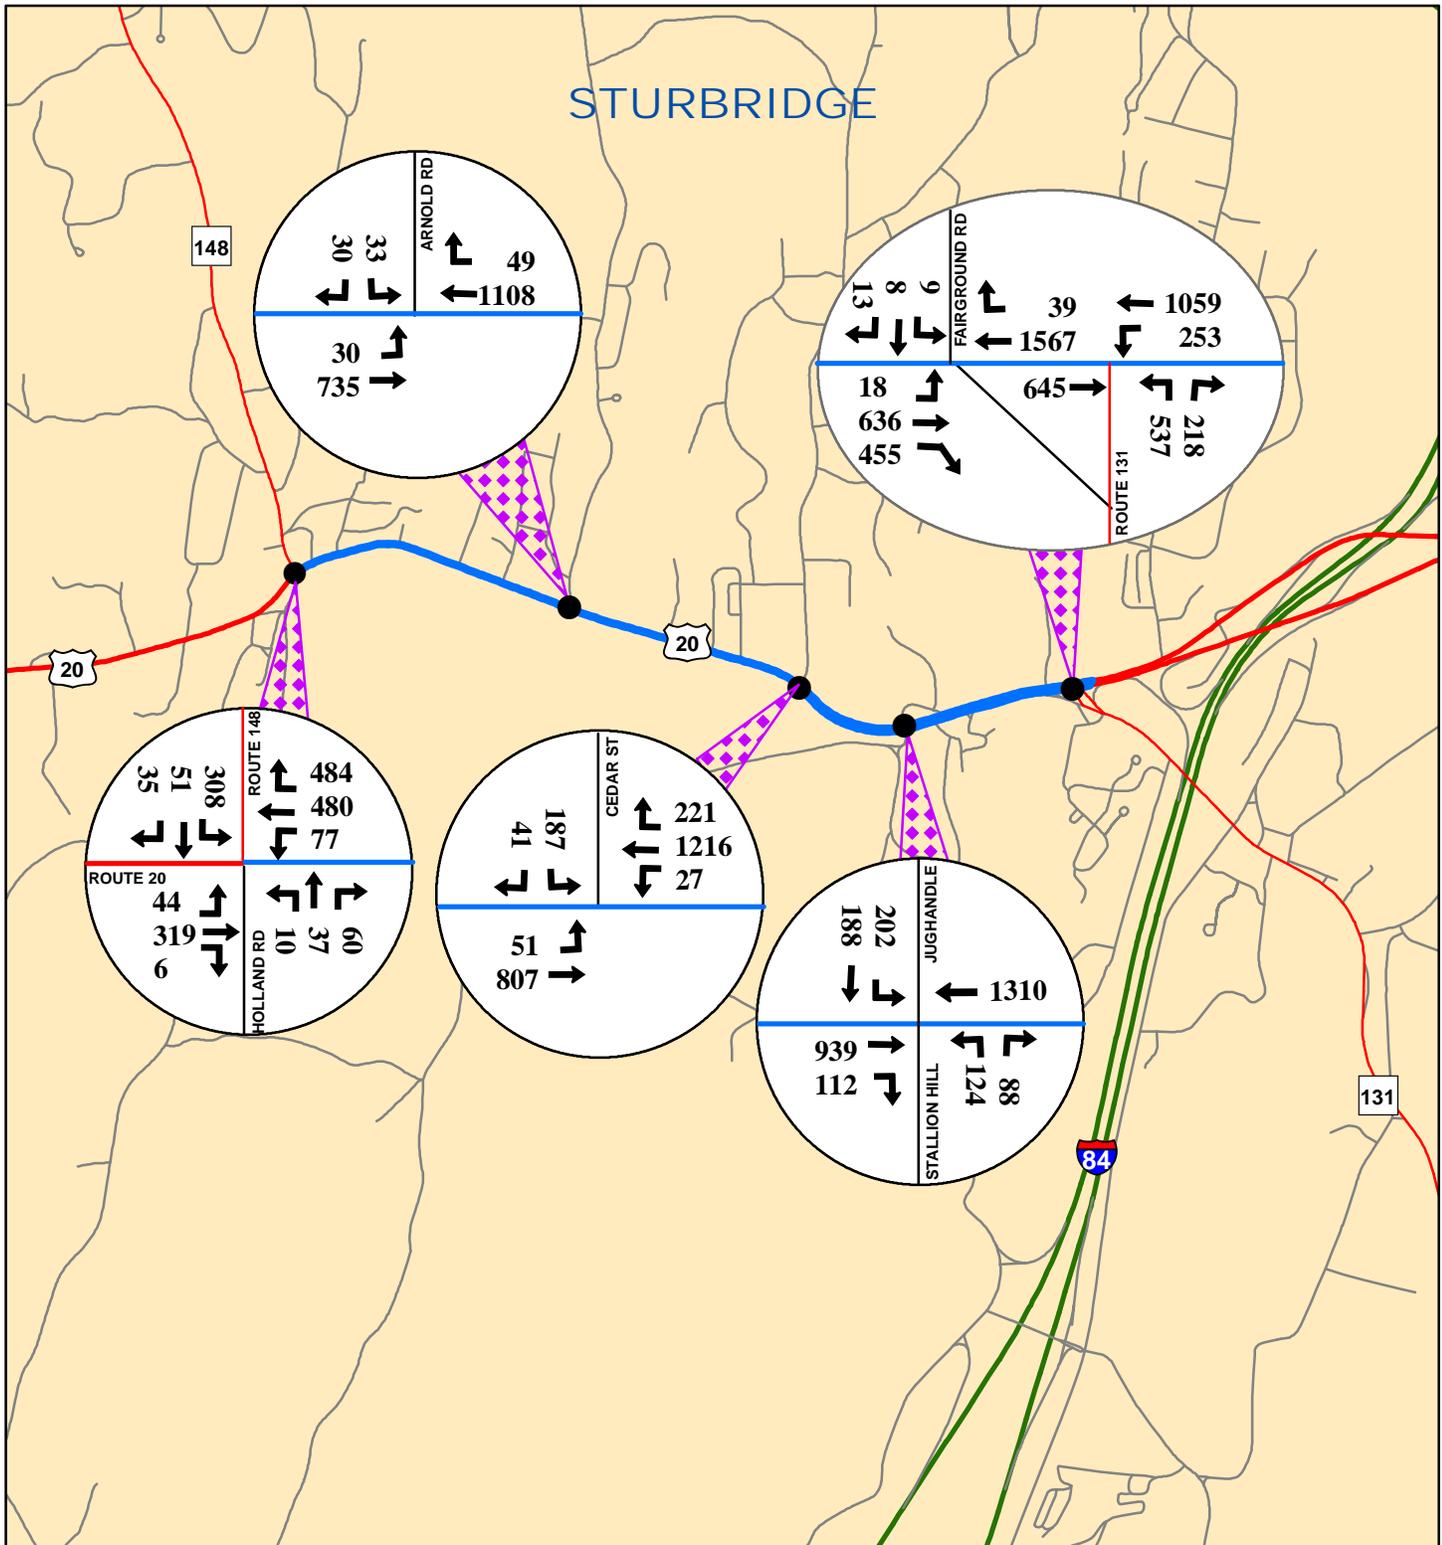
Sturbridge Existing Traffic Flows
PM Peak Hour Period
Figure 14

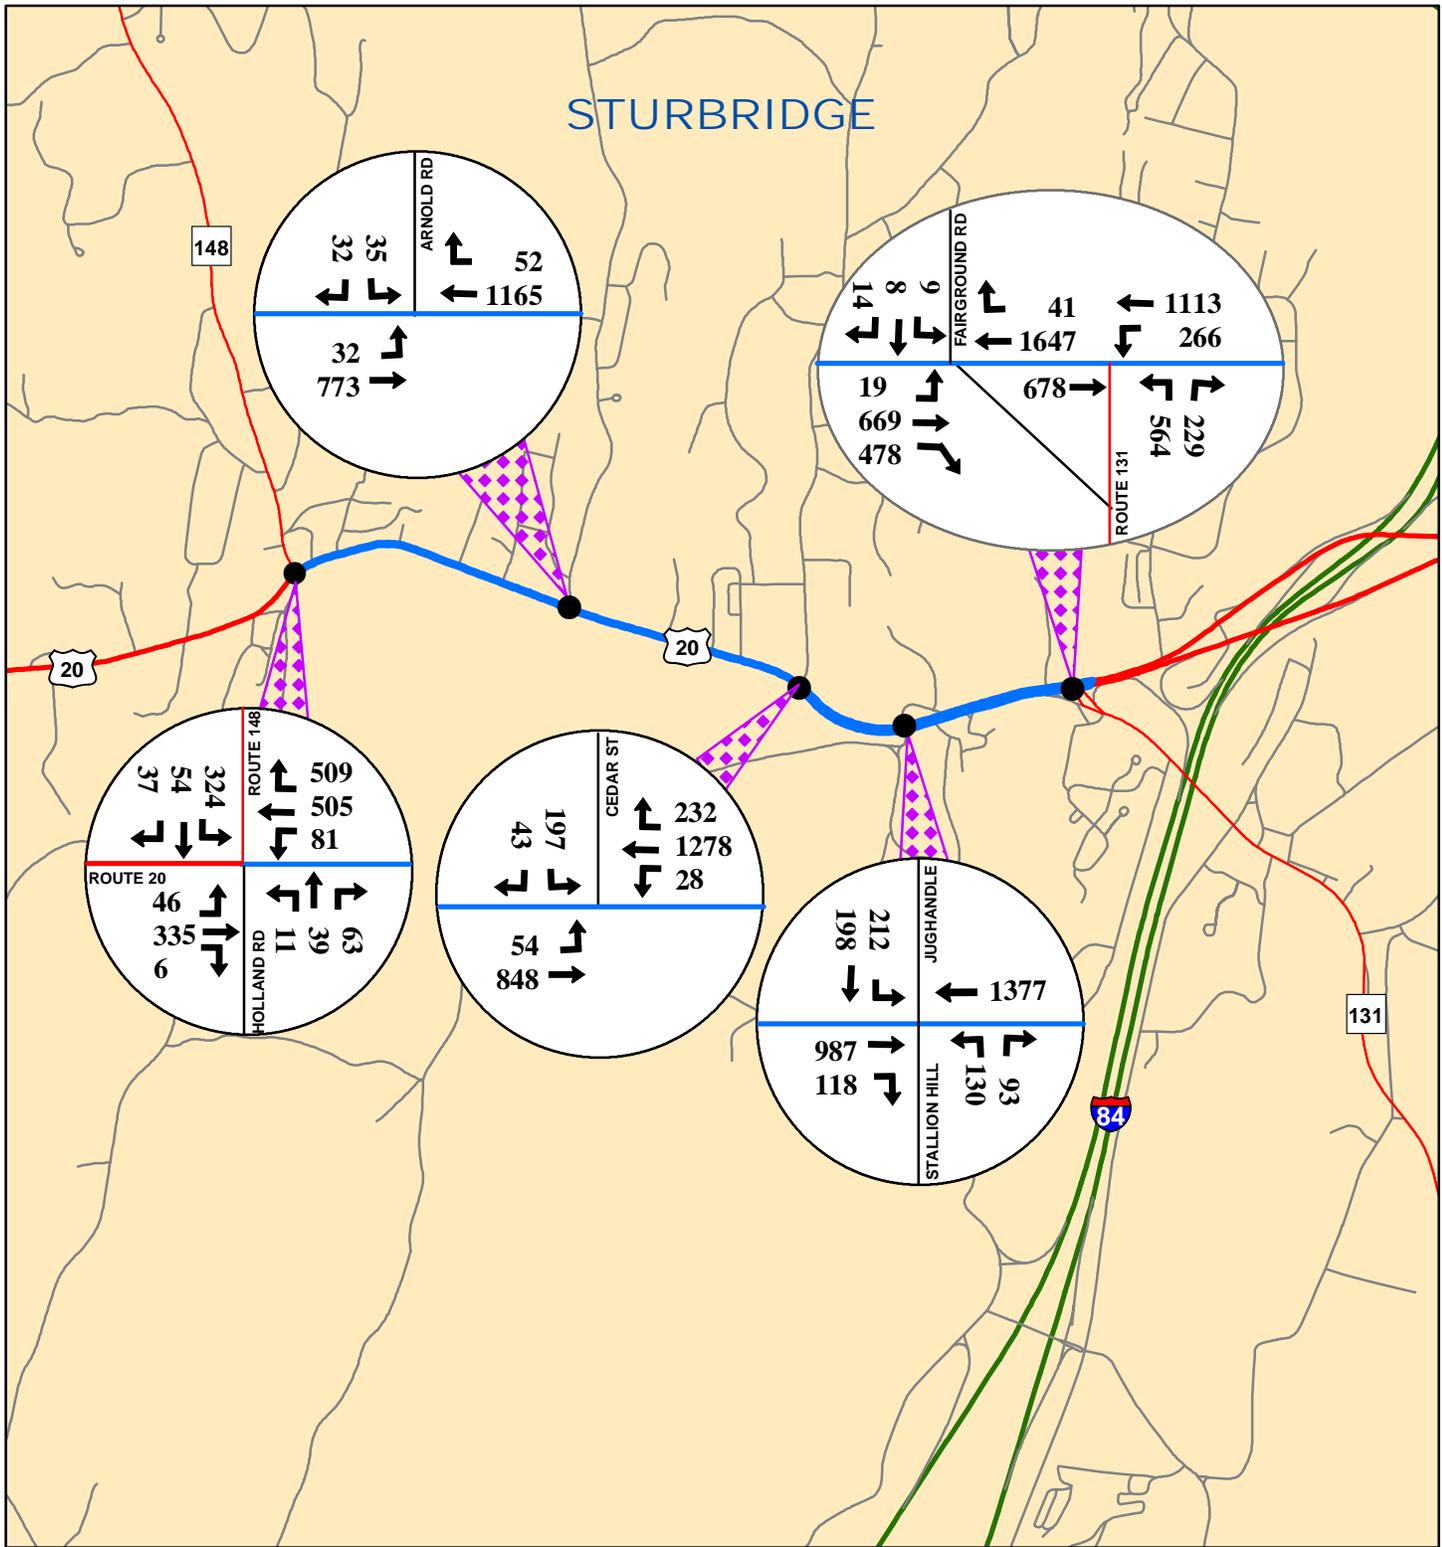
The resulting 2028 traffic flow networks for the AM and PM peak hours were then analyzed to characterize likely future operating conditions. **Figure 15** and **Figure 16** illustrate 10-year projections of the existing volumes, assuming an annual growth rate of 0.5% for the entire length of Route 20 in the town of Sturbridge.

Sturbridge Projected 2028 Traffic Flows
PM Peak Hour Period
Figure 16

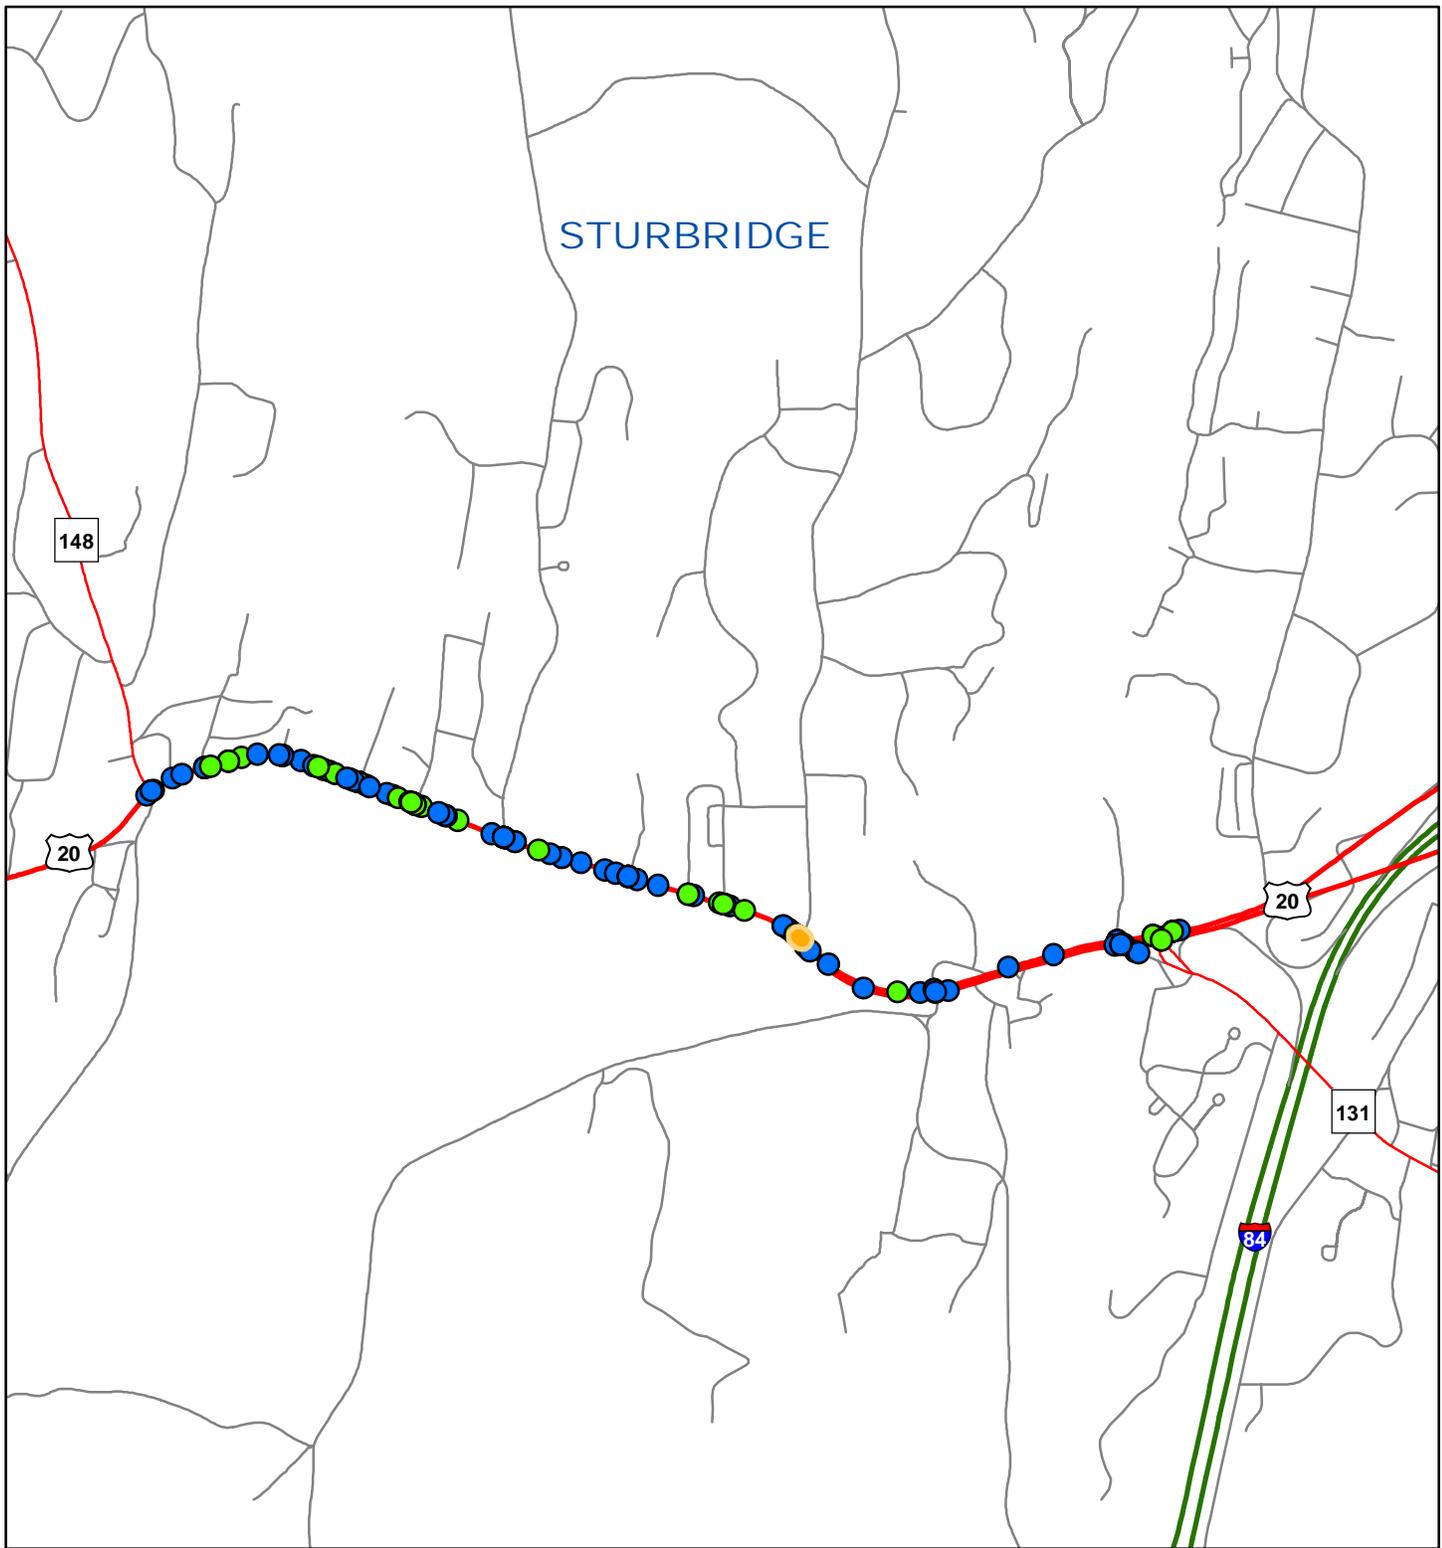
Figure 17 shows the location of the crashes that occurred on Route 20 in Sturbridge between 2014 and 2016. The colored dots on the map indicate whether an incident was a fatal injury, non-fatal injury, or property damage-only type crash. Also included are bicycle and pedestrian incidents. The total count of each crash type is shown in the legend. In addition, the locations of Highway Safety Improvement Program (HSIP) eligible crash clusters are shown on the map. To be HSIP eligible, the clusters need to be within the top 5% statewide. These clusters are defined based on the number of crashes adjacent to one another within a defined radius that has a high incidence of crash severity. MassDOT has developed an automated procedure for processing, standardizing, matching and aggregating the crash data collected by the RMV branch by geographical location using Geographic Information System (GIS) tools and procedures resulting in vehicle crash clusters, bicycle clusters and pedestrian clusters.

For the three-year period that was analyzed for this Corridor Profile, the intersection of Route 20 and Cedar Street was the only HSIP-eligible intersection. At this location there were eight crashes with non-fatal injuries and nine crashes that were property damage only. Of the 17 reported crashes, there were four angle, eight rear-ends, four sideswipes and one single vehicle crash.

Sturbridge Crash Data
Figure 17

There were a total of 154 reported study area crashes in the town of Sturbridge for the three-year analysis period. **Table 7** shows a summary of the crashes in which the details are shown in a variety of ways. Property damage-only crashes accounted for 75% of the total, while non-fatal injuries accounted for 25%. Rear-end crashes were the most prevalent with a total of 78. Angle crashes were second with 47. The two intersections with the most crashes were at Route 131 and Cedar Street. Often the case, most crashes occurred on dry road conditions, in daylight, and in clear weather. The highest number of crashes (43) occurred between 12 PM and 4 PM. The most crashes occurred during the month of June, with the month of May close behind.

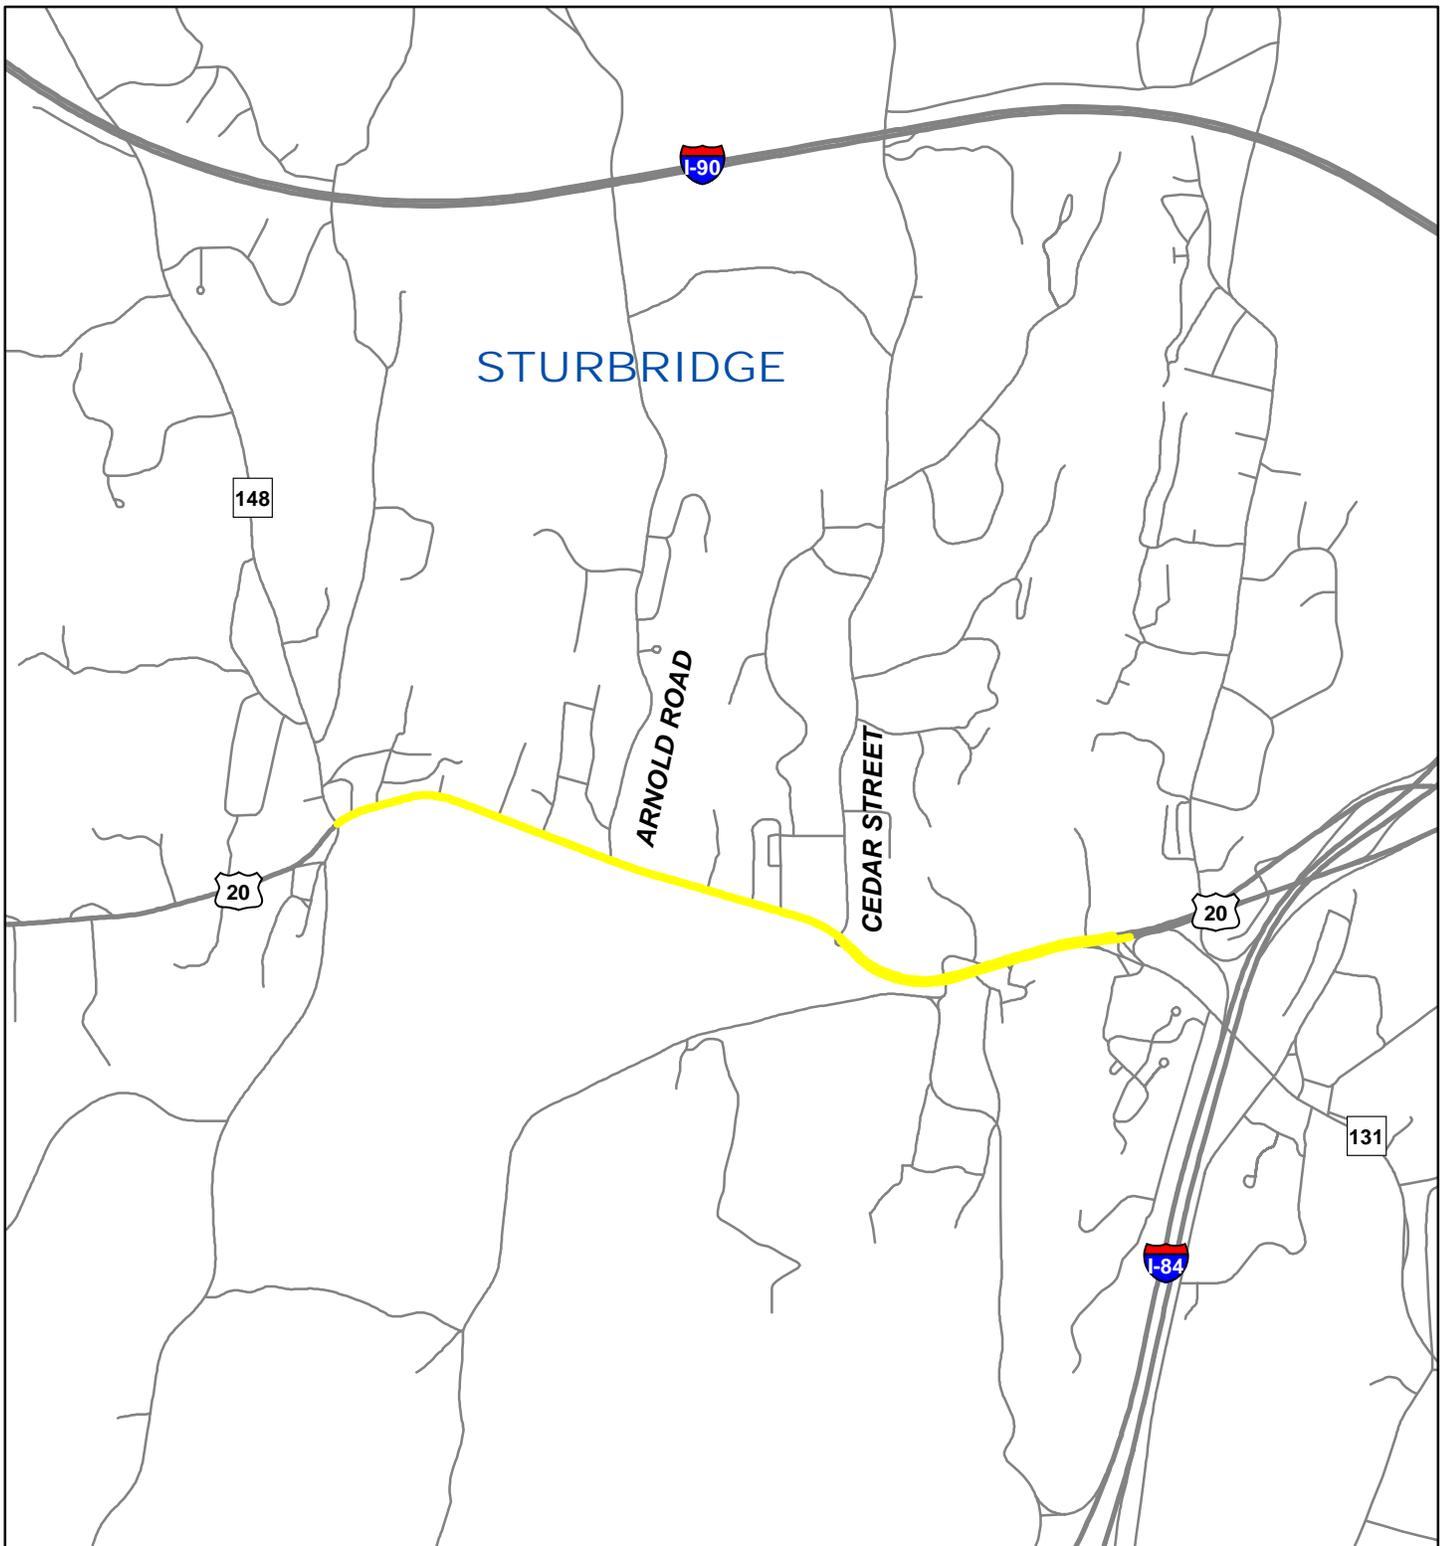
Pavement Condition

Table 10
Sturbridge Route 20 Pavement Analysis Recommendations

Street	From	To	Length	Plan Activity	OCI
Route 20	Route 148	Cedar St	1.05 mi	Preventative Maintenance	57.4
Route 20 (EB)	Cedar St	Route 131	0.55 mi	Preventative Maintenance	61.4
Route 20 (WB)	Route 131	Cedar St	0.55 mi	Preventative Maintenance	64.0

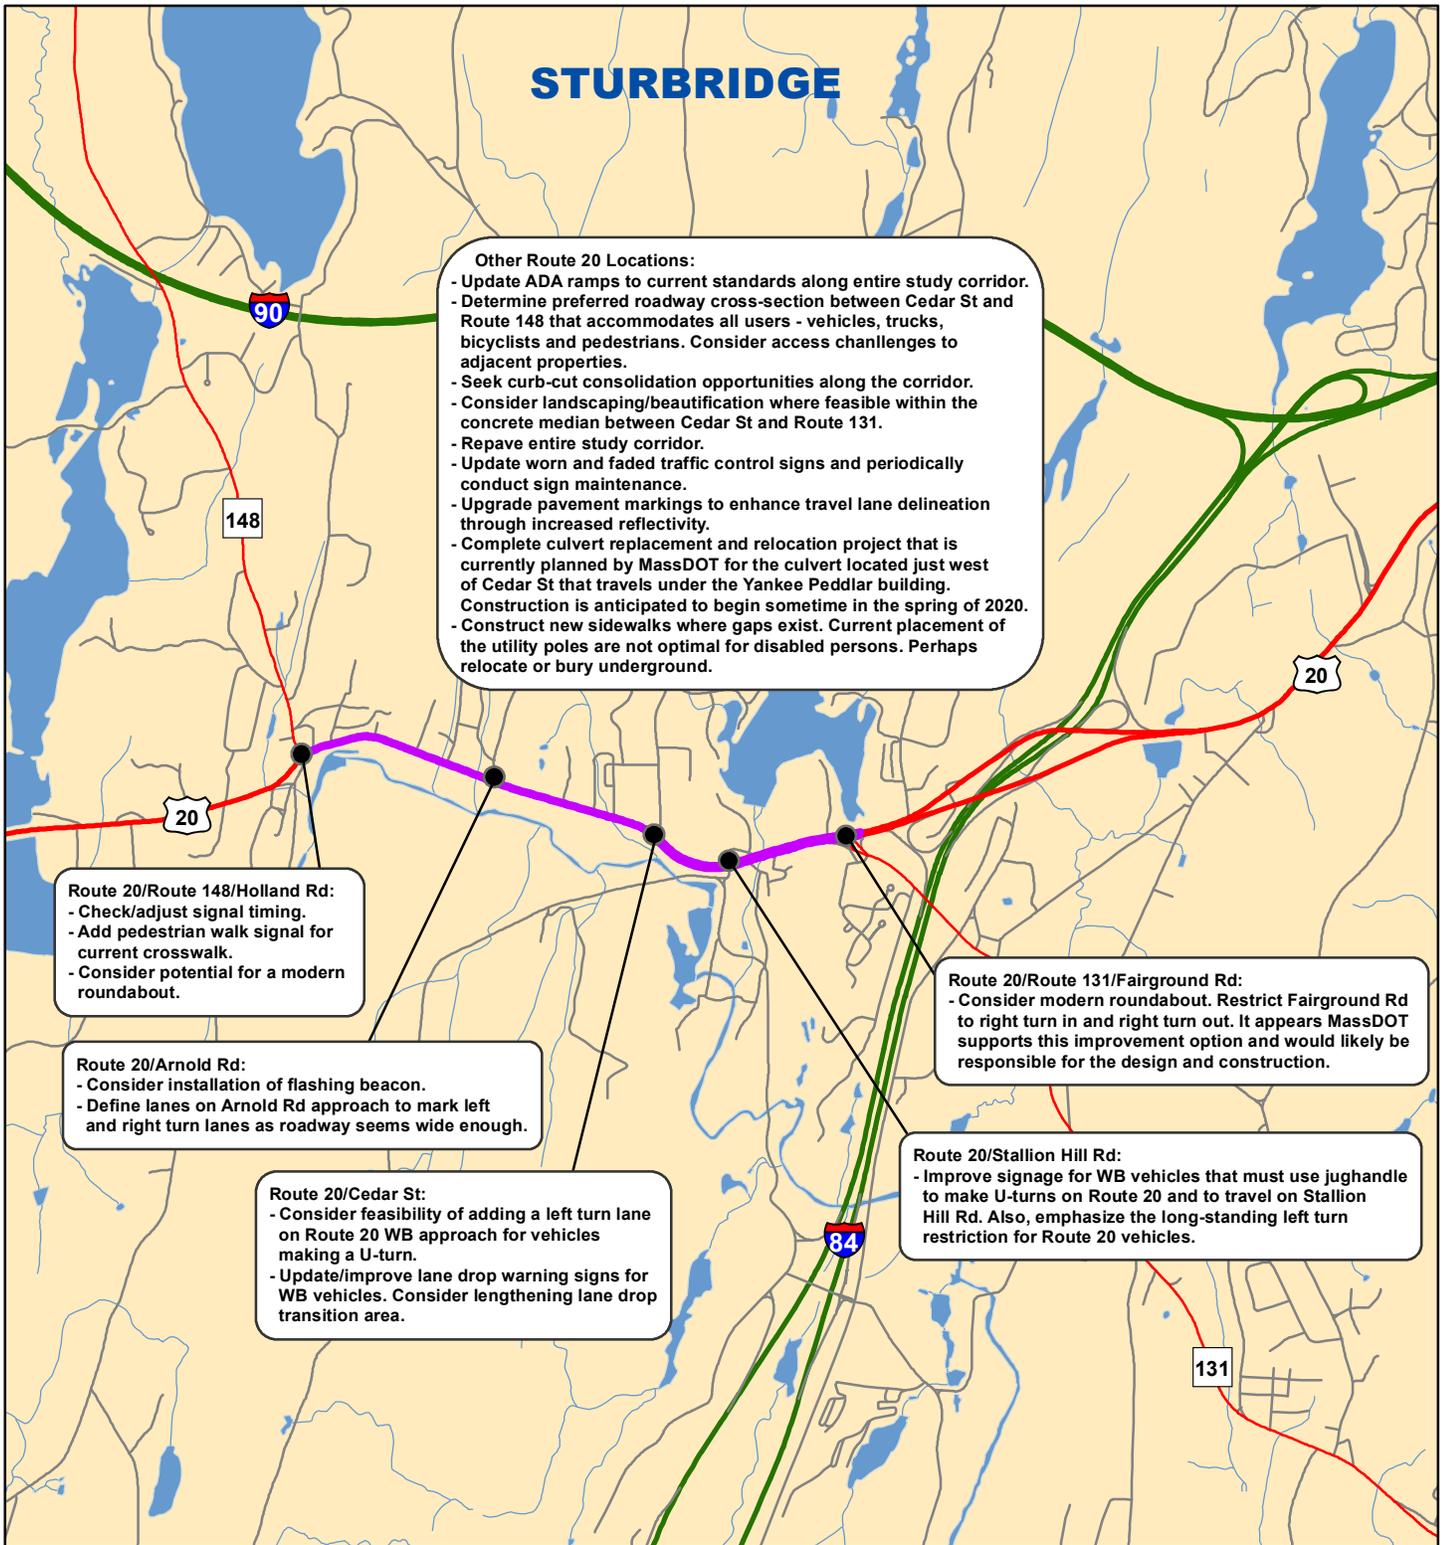
Sturbridge Suggested Improvements

- Upgrade pavement markings to enhance travel lane delineation through increased reflectivity throughout the entire study corridor.
- A culvert replacement and relocation project is currently planned by MassDOT for the culvert located just west of Cedar Street that travels under the Yankee Peddler building. Construction is anticipated to begin sometime in the spring of 2020 with an estimated cost of \$3.9 million. New sidewalks and ADA ramps are also included within the project scope.
