CENTRAL MASSACHUSETTS

West Boylston - Boylston - Shrewsbury Route 140 Corridor Profile

December 2018

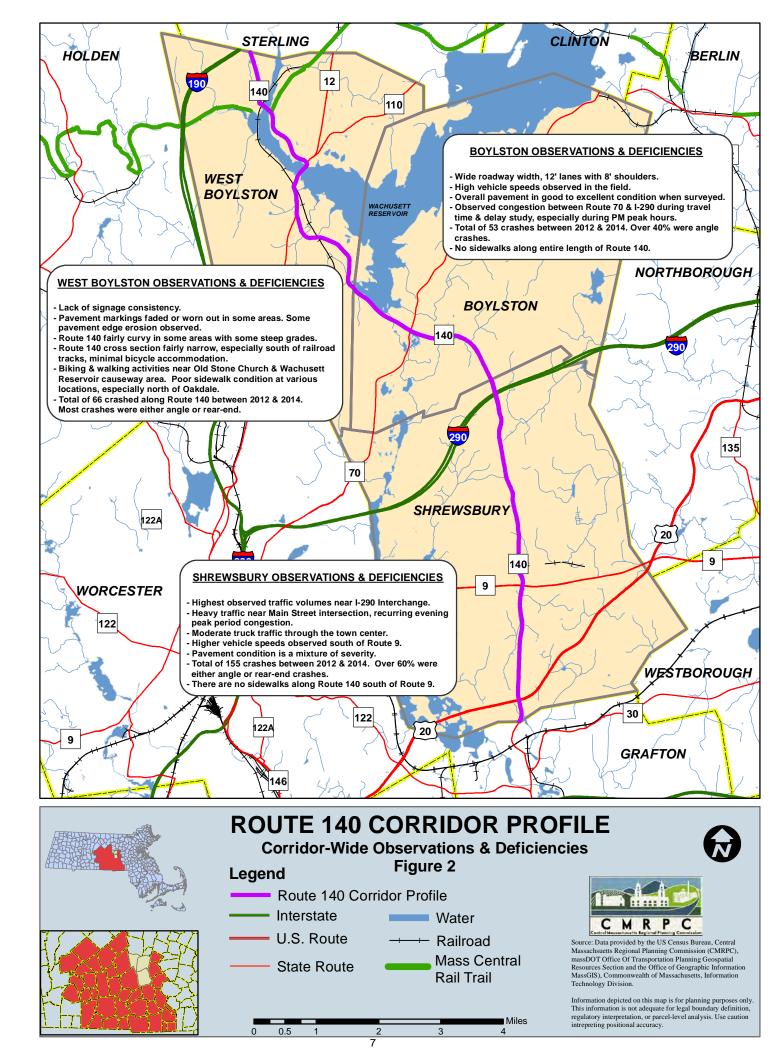
The following corridor-wide existing deficiencies, also shown in **Figure 2**, were observed along the entire length of the Route 140 study area:

- Signage issues lack of consistency of warning, speed limit, and regulatory signs. Signs missing at some locations. Areas of sign clutter.
- Pavement maintenance markings faded or worn out in some areas. Near the Boylston town line the existing pavement condition is below average. Edge drop off and erosion also an observed issue.

- Bicycle & Pedestrian accommodations there are biking & walking activities near Old Stone Church and Wachusett Reservoir causeway area. Poor sidewalk conditions at various locations.

- Wide roadway width, 12' lanes with 8' shoulders.
- High vehicle speeds observed in the field.
- Overall pavement in good to excellent condition when surveyed.
- During the travel time & delay study, traffic congestion was observed between Route 70 and I-290, especially during PM peak hours.
- There were 53 total crashes between 2012 and 2014. Over 40% were angle crashes.
- There are no sidewalks for the entire length of Route 140 through the town of Boylston.

- Highest observed traffic volumes near I-290 Interchange.
- Heavy traffic near Main Street intersection, recurring evening peak period congestion.
- Moderate truck traffic through the town connecting to other major routes.
- Higher vehicle speeds observed in the field south of Route 9.
- Half of the pavement is in either good or excellent condition while the remaining pavement was observed to be in fair or poor condition.
- There were 155 (most of the three corridor host communities) total crashes between 2012 and 2014. Over 60% were either angle or rear-end crashes.
- There are no sidewalks along Route 140 south of Route 9 all the way to the Grafton town line.

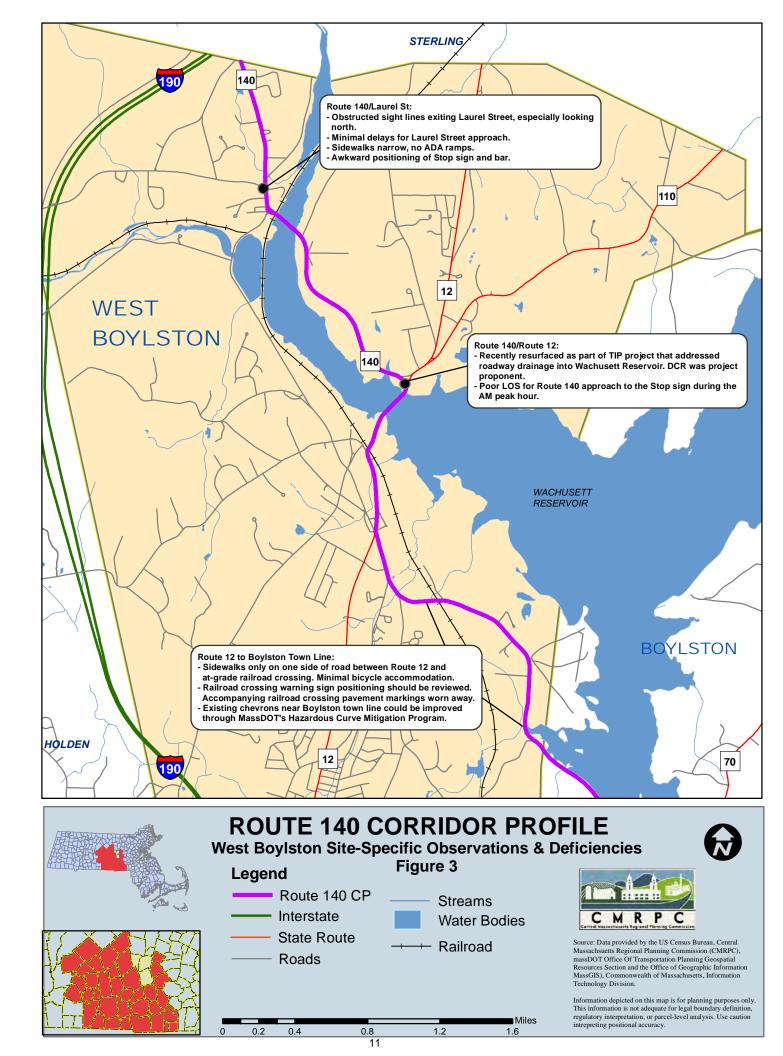
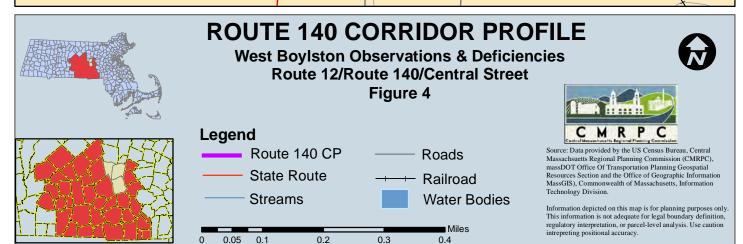
WEST BOYLSTON

The following site-specific existing deficiencies, also shown in **Figures 3 and 4**, were observed along the West Boylston segment of the Route 140 study corridor:

- The opposing Route 12 NB & SB left turn lanes are not optimally aligned.
- Existing pedestrian phase signal equipment appears to be corroded and could be a candidate for replacement and upgrades.

- Route 12 northbound approach recently paved, no more rutting or wheel path deterioration is evident.
- The Route 12/Route 140 southbound left turn to the Route 140 southbound departure lane is somewhat narrow, just under 11' in width. Further, vehicles from Route 12 northbound making a right turn to Route 140 southbound using the curved, channelized turn lane, need to be cautious of Route 140 flows.

- Route 140 northbound vehicle queues have been observed to measure approximately one-half mile during the evening peak travel period at 4:00 PM.
- Route 140 northbound left turning maneuver to Route 12 southbound is difficult, due to sharp turn angle; requires large trucks to cross opposing travel lanes.

- Route 140 northbound transition of this approach to the alignment of the Route 12/140 northbound departure lane has a somewhat poor transition area; observed to be potentially confusing for those unfamiliar with location.

- Lane use is somewhat confusing because of acute roadway geometry. Frequent "near misses" of Route 140 SB and Route 12 NB traffic observed in field.
- Pedestrian accommodations Limited; crosswalk by Honey Farms not signal controlled. Observations showed pedestrians cross when they want or are simply able to.

Central Street Southbound Approach:

Route 12 Northbound Approach: - The approach lanes recently repaved, no more rutting or wheel path deterioration is now evident.

- Second highest crash total for a study intersection. HSIP eligible.
 Travel & turning lanes are overall somewhat narrow, most <11' in width.
- Intersection alignment, due to the acute angle of the intersecting roadways, has been observed to lead to driver "confusion".

- Traffic signal heads are at odd angles, potentially confusing drivers to know which signal is facing them.
- Observed pedestrians crossing when and where they want.

- Vehicle queues have been observed to measure approximately one-half mile during the evening peak travel period beginning at 4:00 PM.
- Left turning maneuver to Route 12 southbound is difficult, due to sharp turn angle; requires large trucks to cross opposing travel lanes.
- The transition of this approach to the alignment of the Route 12/140 northbound departure lane has a somewhat poor transition area; observed to be potentially confusing for those unfamiliar with location.

- Increased volume of traffic observed turning at this intersection.
 Franklin St used as a cut-through to Route 12 to avoid left
- turn at signalized Route 12/140 intersection.

- Only one reported crash at this intersection between 2012 and 2014.
- Minimal delays for the Franklin Street approach.
- Franklin Street approach fairly narrow with limited bicycle accommodation. Sidewalks provided on entire north side and half of the southern side.

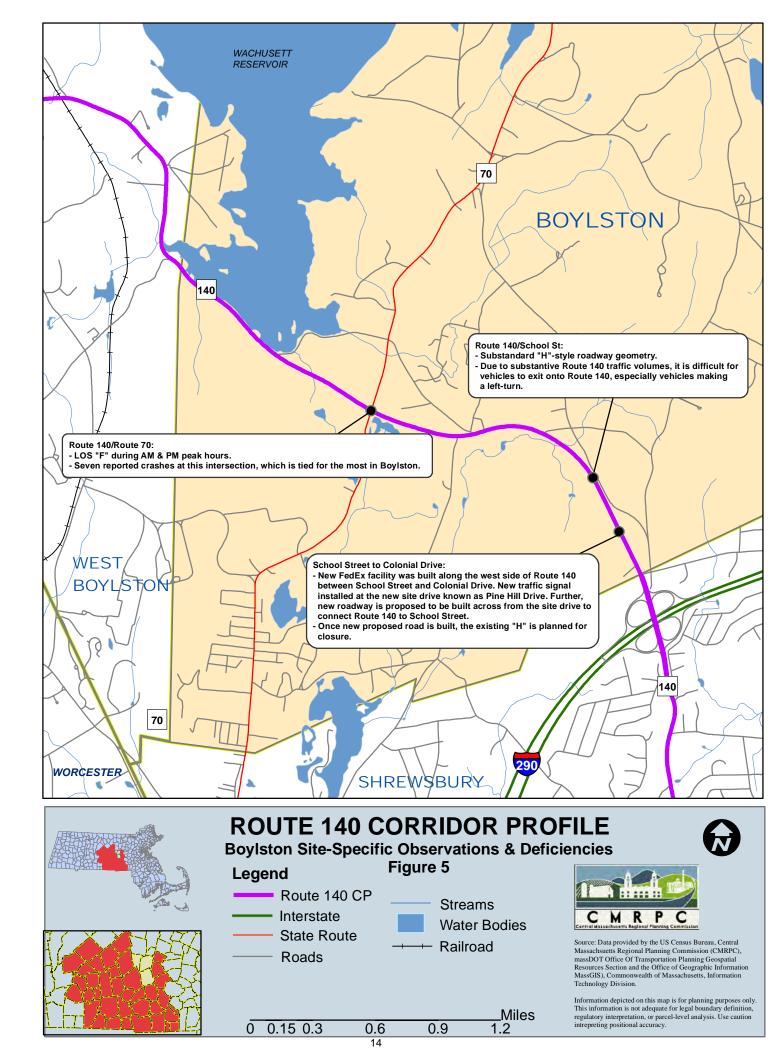
The following site-specific deficiencies, also shown in **Figure 5**, were observed along the Boylston segment of the Route 140 study corridor:

- There is a new FedEx facility that has been built along the west side of Route 140 between School Street and Colonial Drive. There is a new traffic signal at the FedEx site drive known as Pine Hill Drive. Further, a new roadway is proposed to be built across from the FedEx site drive to connect Route 140 to School Street.
- With construction of Pine Hill Drive, between Route 140 and School Street, the existing "H" is proposed for closure.

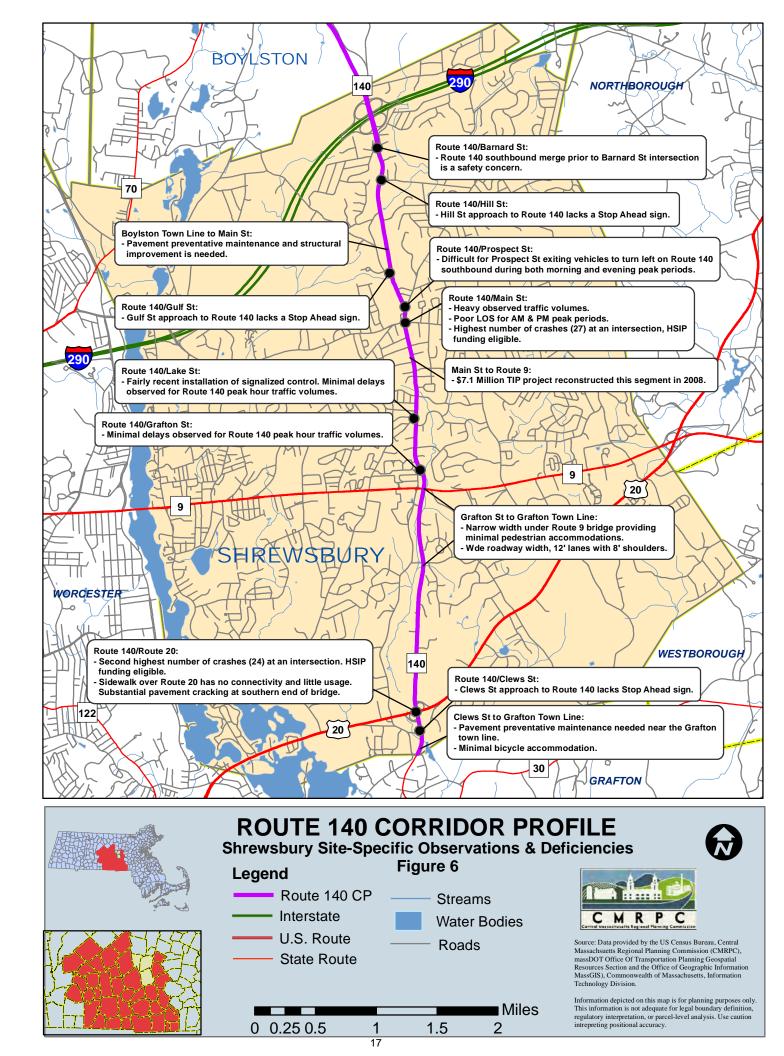
The following site-specific deficiencies, also shown in **Figure 6**, were observed along the Shrewsbury segment of the Route 140 study corridor:

- Heavy observed traffic volumes.
- Poor level-of-service for AM & PM peak periods.
- Highest number of crashes (27) along Route 140 segment in host community of Shrewsbury. Considered a crash cluster, this location is eligible for Highway Safety Improvement Program (HSIP) funding.

• Fairly recent installation of signalized control. Minimal delays observed for Route 140 peak hour traffic volumes.

• Minimal delays observed for Route 140 peak hour traffic volumes.

- Based on observations in the field, pavement preventative maintenance and structural improvement is needed between Main Street and the Boylston town line.
- Gulf Street approach to Route 140 lacks a Stop Ahead sign.
- Hill Street approach to Route 140 lacks a Stop Ahead sign.
- Route 140 southbound merge prior to Barnard Street intersection is a safety concern.

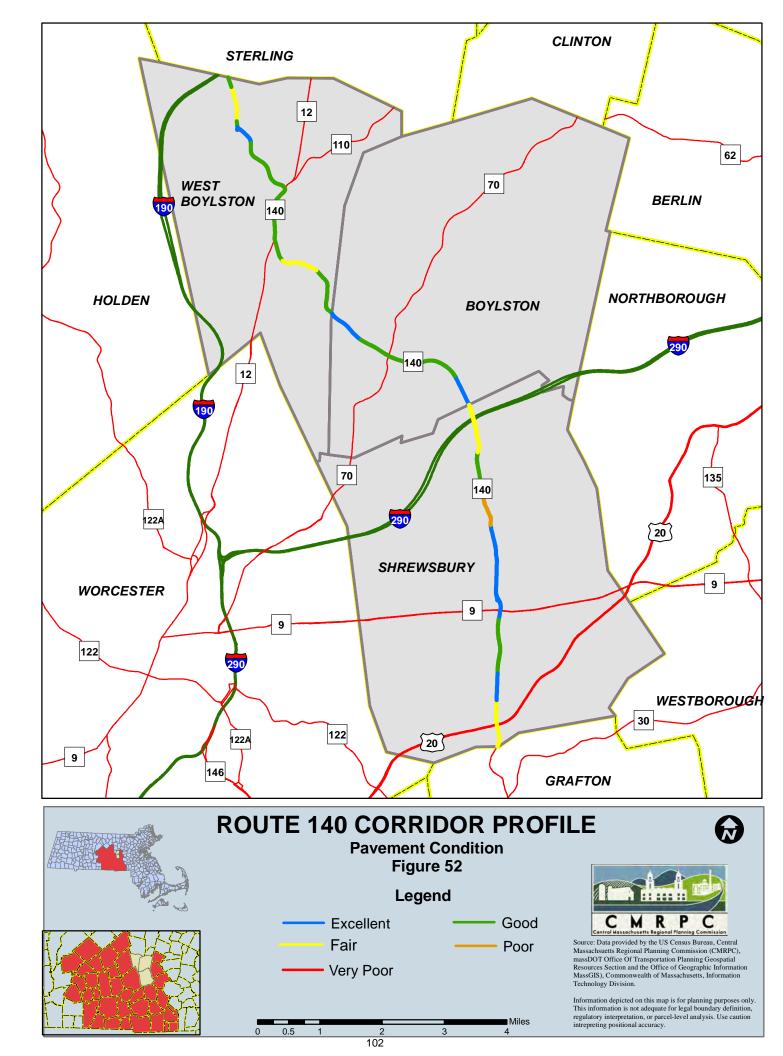
Figure 52 displays the current pavement conditions for Route 140 represented by Overall Condition Index (OCI) Recommended Action. *Cartegraph* produced OCI Recommended Action categories that suggest the type of action necessary to bring a road segment to "Excellent" condition. **Table 16** shows the OCI and Recommended Action for each roadway segment.

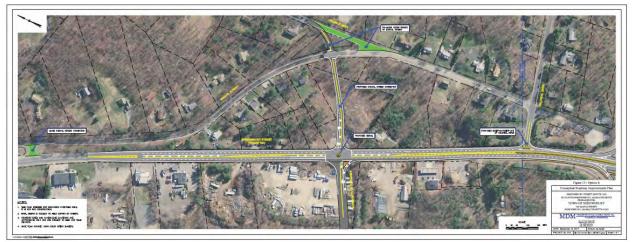
Route 140 Conceptual Roadway Improvement Plan

Concurrent with the anticipated construction/installation of Pine Hill Drive (East) to School Street, the existing School Street "H"-style intersection is planned for closure. A lengthy crash history is associated with this substandard intersection design. Further, with Pine Hill Drive (East) in place, Colonial Drive will be limited to "Right-In/Right-Out-Only" through the installation of a large traffic island and regulatory signage. Colonial Drive traffic volumes will utilize Pine Hill Drive (East) to access Route 140 southbound. Below is a conceptual improvement plan of this planned improvement.

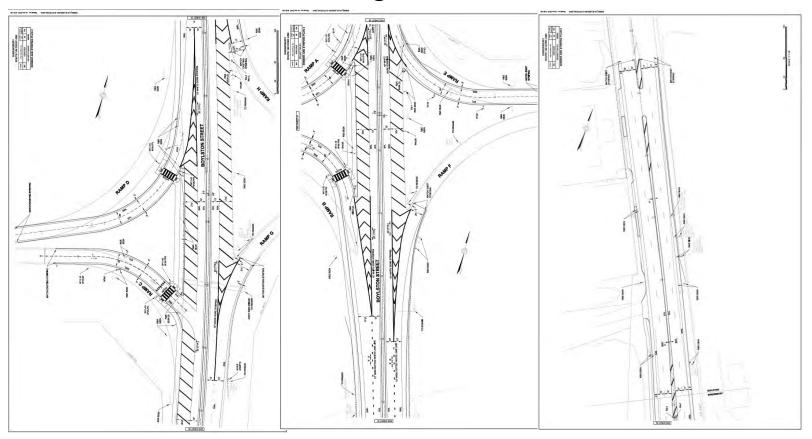
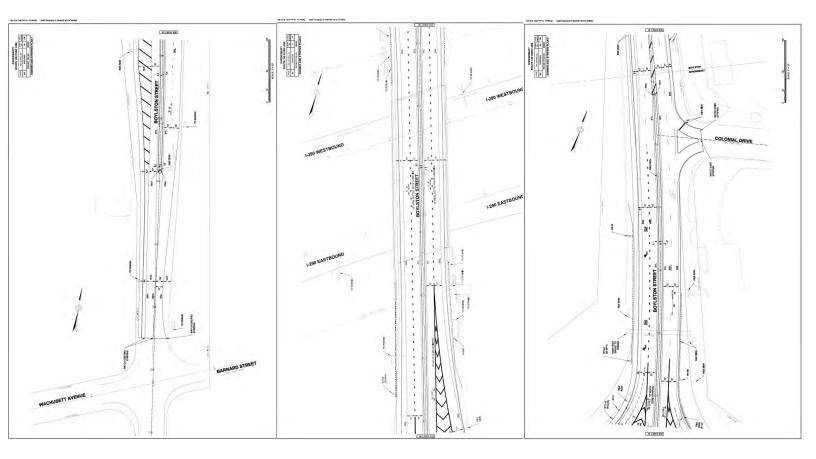
Route 140 Bridge over I-290 Replacement Design Plan Figure 59

Route 140 Northbound: When departing the Wachusett Avenue/Barnard Street intersection, one travel lane is provided approaching the interchange area. At the onramp for I-290 eastbound, one lane will continue on Route 140 northbound while the other will be for "Right Turns-Exit Only" to I-290 eastbound. Beginning at the off ramp from I-290 eastbound to Route 140 northbound, Route 140 on the bridge accommodates two lanes, one for northbound through travel and the other auxiliary lane for acceleration/deceleration, merging/weaving maneuvers prior to the I-290 westbound on-ramp. At this point, one lane will continue on Route 140 northbound, and is then joined by the ramp from I-290 westbound to Route 140 northbound. A "road diet" concept for Route 140 at this point will serve to reduce the number of northbound lanes where the off-ramp meets Route 140 from three (3) existing to two (2) proposed. These two Route 140 northbound travel lanes will match the existing lane geometry of Route 140 south of Pine Hill Drive. Again, Colonial Drive will be limited to "Right-In/Right-Out-Only" through the installation of a large traffic island and regulatory signage.
