ROAD SAFETY AUDIT

Bartlett Street

Town of Northborough

10/28/2021

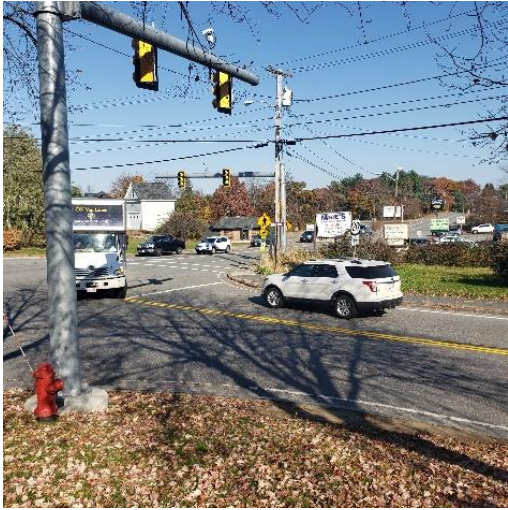
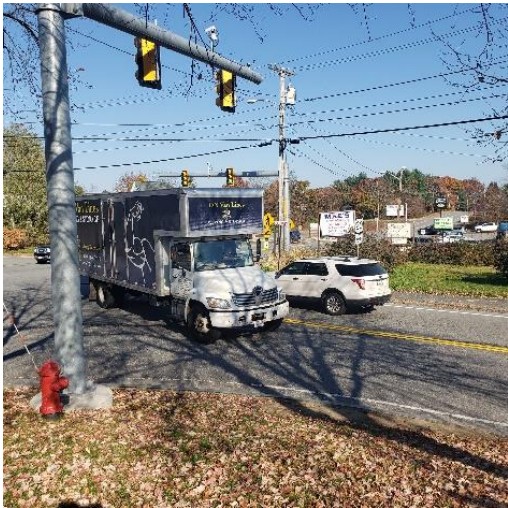
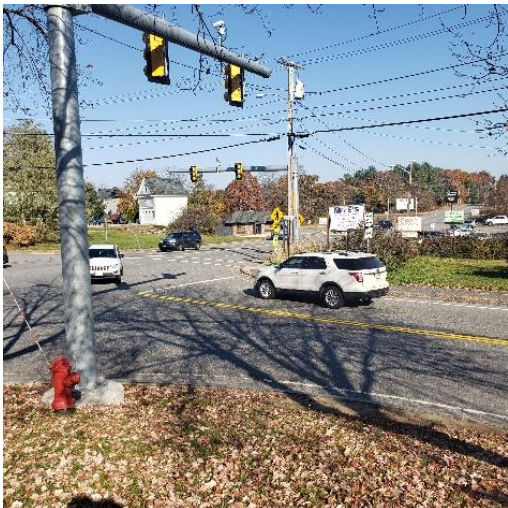
Figure 7: Vehicle Stopped Behind Line to Allow Truck Movement

Observations: It was observed that large vehicles such as tractor trailers or school buses had difficulty turning onto Bartlett Street from both sides of Main Street. This was made evident at the RSA as tire marks were observed over the curb in the grass from vehicles turning right on to Bartlett Street from Main Street (eastbound) (have photos). The RSA team also commented on lack of adequate pedestrian infrastructure given the high usage of high school students using the intersection to access their homes and retail establishments on both sides of Main Street. Among the four approaches to the intersection there is only one signalized crosswalk that is on the east side of the intersection. Residents voiced concerns that right-on-red turning movements are allowed and that many drivers do not pay attention to pedestrians in the crosswalk when attempting to make a right-turn maneuver from Bartlett Street onto EB Main Street. Additionally, there are only sidewalks on one side of Bartlett Street and no sidewalks on Main Street despite access to retail businesses and Saint Bernadette’s School at the intersection.

- Work with MassDOT to develop long term design recommendations for the intersection. The design should include accommodations for trucks turning in and out of Bartlett Street and pedestrian improvements at the intersection and access to retail businesses on Main Street.
- Work with MassDOT as a short-term measure to consider moving back the stop bar on Bartlett Street to allow for additional turning radii for trucks turning into Bartlett Street.
- Work with MassDOT to evaluate current signal timing with special attention for left turns onto Main Street.
- Work with MassDOT to evaluate short and/or mid-term improvement for right turns from Main Street EB into Bartlett Street SB and Bartlett Street NB to Main Street EB.

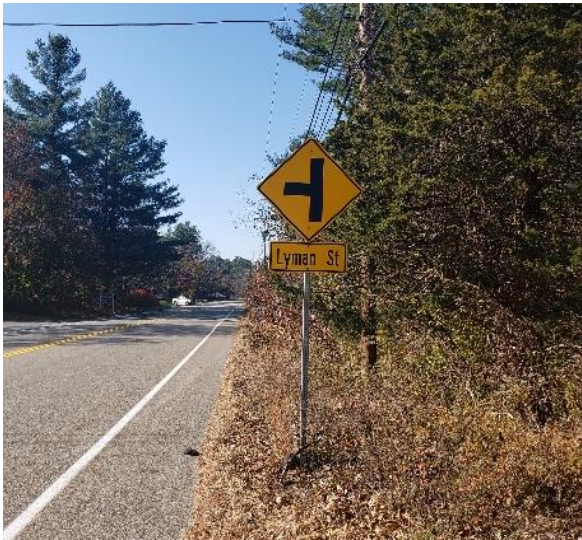
Figure 16: Signage Informing of Lyman Intersection

Observations: The intersection of Bartlett Street and Lyman Street had some major concerns during the RSA. Despite a 'stop sign ahead' on Lyman St approaching Bartlett St., residents and observers at the RSA noted that the actual stop signs on Lyman Street at Bartlett Street seem to sneak up on drivers. There have been multiple accidents at this location. During the RSA, there was no longer a guardrail on Bartlett Street as two vehicles had recently crashed through it. Another observation was that vehicles traveling on Bartlett Street predominantly WB occasionally stop although there is no stop sign on Bartlett Street (courtesy stops) for vehicles making a left turn onto Bartlett Street while exiting Lyman Street. This action often causes confusion for drivers behind the stopped vehicle on Bartlett Street causing hazardous driving behavior. There is signage directing traffic to Route 495 at the end of Lyman Street and the intersection has a streetlight.

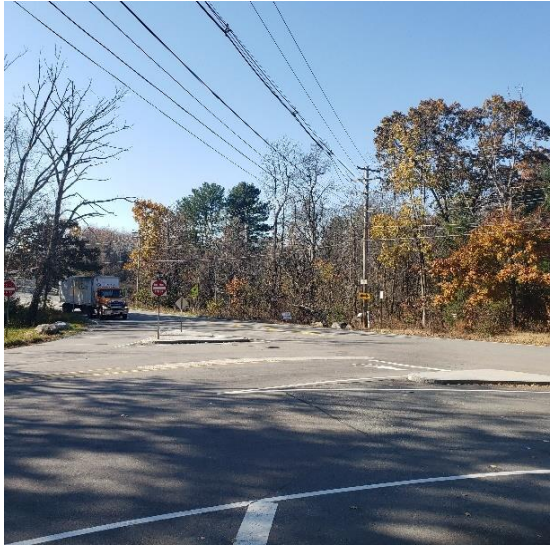
Figure 22: Cedar Hill Road Geometry after Redesign

Observations: The intersection was recently designed with new channelized islands and geometry. Stakeholders and residents at the RSA were generally happy with the redesign. Participants at the RSA made note of the poor pavement condition of Cedar Hill Street in Marlborough. A representative of ARHS also stated that the pavement conditions on Cedar Hill Street in Marlborough was one of their biggest concerns for student (teen driver) safety. A lack of lighting was noted at the intersection. Pedestrian infrastructure exists west of the intersection on Bartlett and the Aqueduct trail.

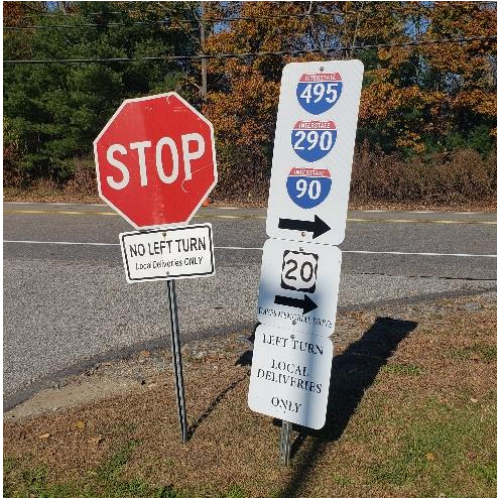
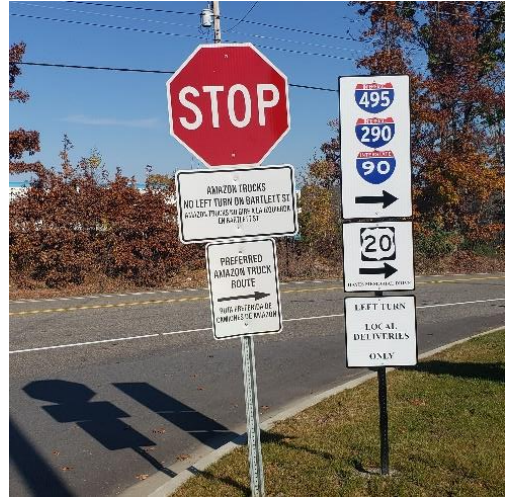
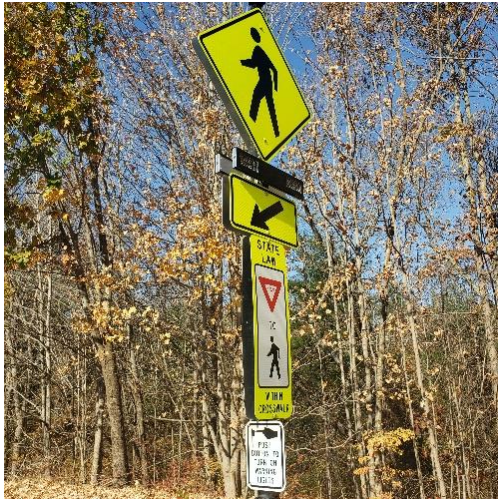
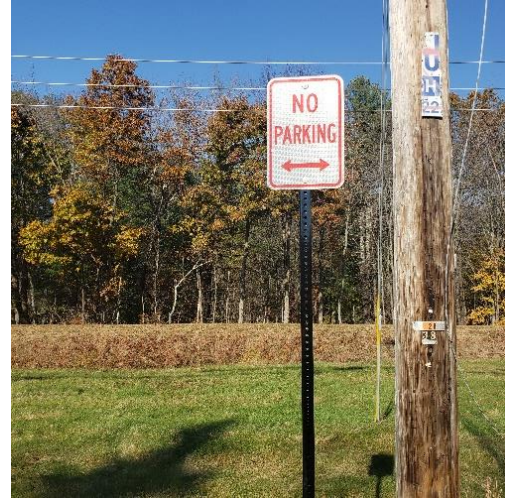
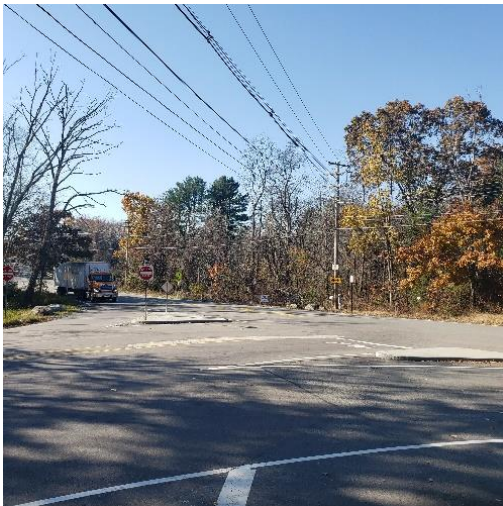
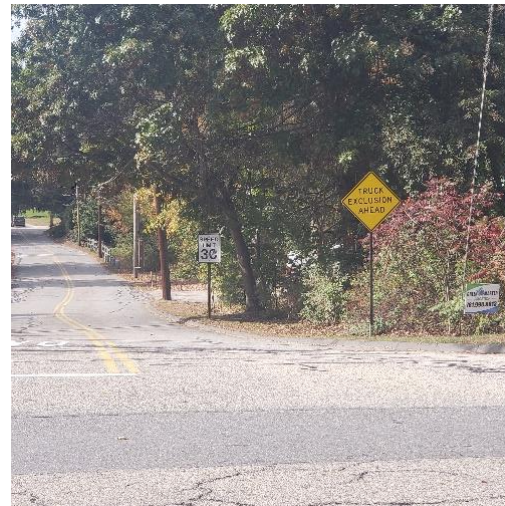
Figure 40: Corridor Improvements and Signage

- No Parking Zone throughout the Bartlett Street Corridor
- Installation of Rectangular Rapid Flashing Beacons at two crosswalks
- Truck exclusion on Maple Street
- Directional Signage at Amazon and A Duie Pyle, Inc. driveways
